# **SILTATION OF AUSTRALIAN RESERVOIRS : SOME OBSERVATIONS AND DAM SAFETY IMPLICATIONS**

H. CHANSON and D.P. JAMES

Department of Civil Engineering, The University of Queensland, Brisbane QLD 4072,  
Australia

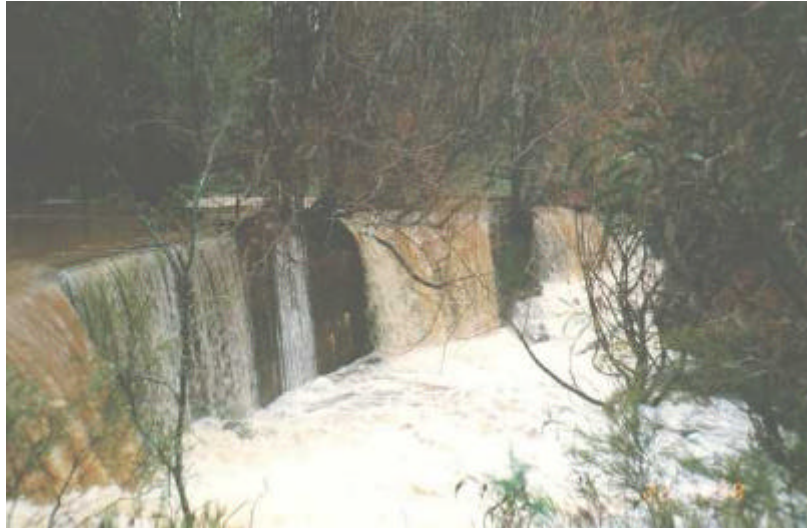
Fig. 2 - De Burgh dam, Baren Jack NSW, 1908 (Photograph in July 1998)  
 H = 5 m - Fully-silted railway reservoir

The above calculations are optimistic because they do not take into account the presence of trees and bush at the dam crest. In several cases (e.g. Moore Creek, de Burgh, Korrumbyn Creek), a forest occupies the reservoir and trees sit on the dam crest. The obstruction caused by the trees would cause a backwater effect associated with an additional wall surcharge (e.g. Fig. 2) !

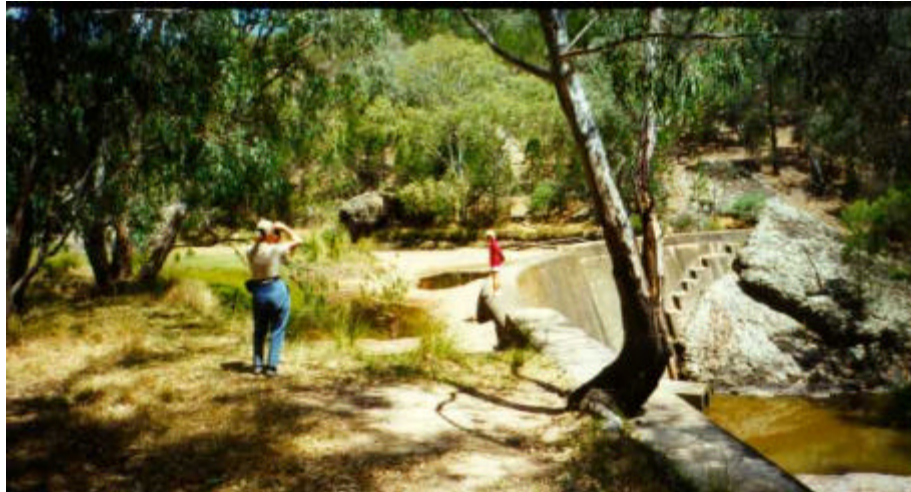
Fig. 3 - Koorawatha dam (No. 2), Koorawatha NSW, 1911 (Photograph on 28 December 1997)H = 9.1 m - Fully-silted railway reservoir

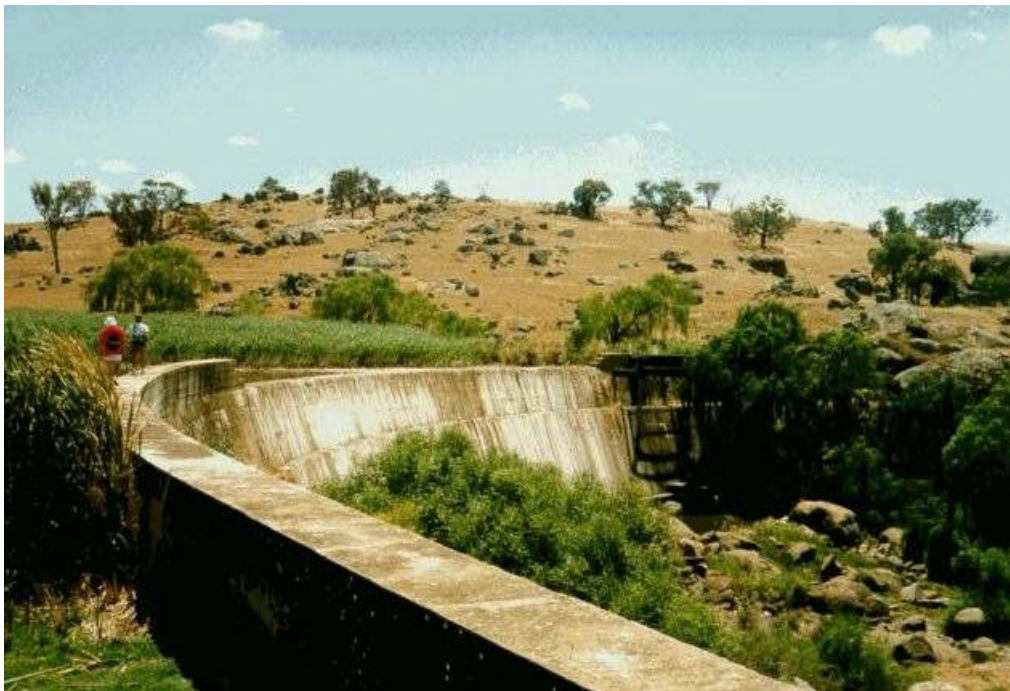
Fig. 4 - Cunningham Creek dam, Harden NSW, 1912 (Photograph on 28 December 1997)

$H = 16 \text{ m}$  (?),  $e = 0.93 \text{ m}$  - Fully-silted railway reservoir since the 1930s

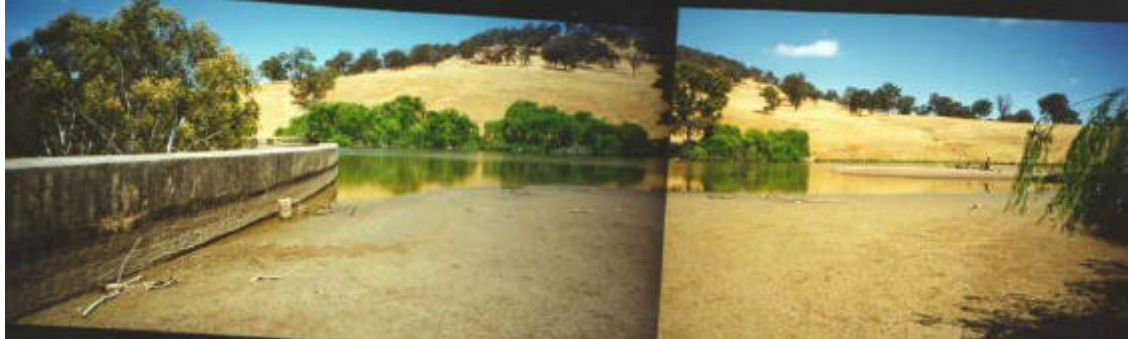
Fig.5 - Illalong Creek dam, Binalong NSW, 1914 (Photograph on 28 December 1997)

Surprisingly most Australian dams have been inadequately equipped with flushing devices. Some did not have scour pipe (e.g. Gap weir 1902). Most reservoirs were equipped with a small scour outlet ( $\varnothing = 0.3$  to  $0.5$  m) inadequate to desilt a reservoir. For example, DARLEY (1900) recommended a "24-inch" diameter outlet. Only few dams were equipped with two or more flushing systems : e.g., the Illalong Creek dam (1914, Binalong NSW) completed in 1914 and now fully-silted (Fig. 5) !

H = 11.3 m, L = 170 m, R = 91.4 m - Fully-silted railway reservoir, despite two scour outlets
