A review of accidents and failures of stepped spillways and weirs

H. Chanson, ME, ENSHM Grenoble, INSTN, PhD(Cant), DEng(Qld), EurIng, MIEAust, MAHR

Proc. Instn Civ. Engrs Water & Mar. Engng, 2000, 142, Dec., 177-188

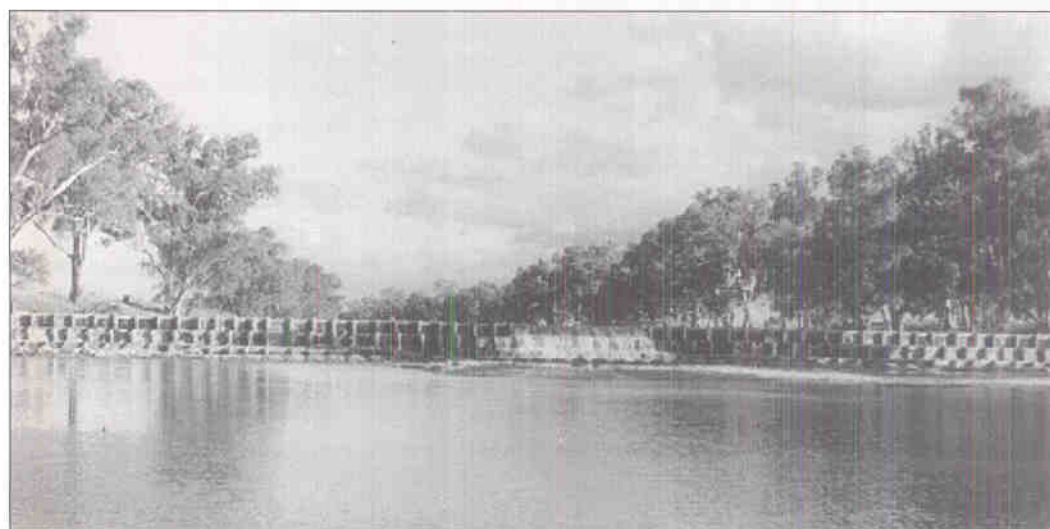
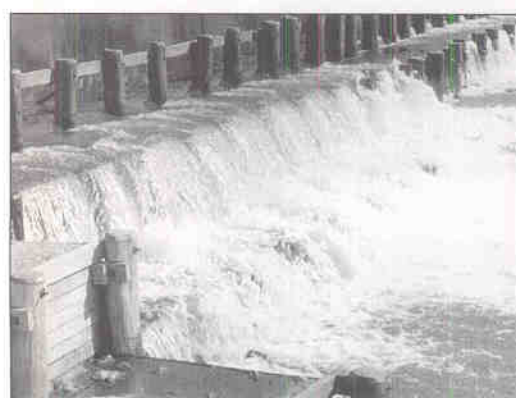
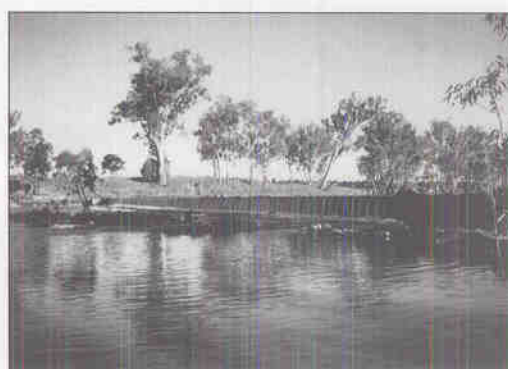
7. The (first) Bonshaw Weir was completed in May 1953 (Fig. 3). Located on the Dumaresq River, it was designed for irrigation water, the primary industry being tobacco. The 3.7 m high weir was a timber crib piled structure (144.5 m long), designed with four steps ($h = 0.9$ m).

8. A major flood occurred in January and early February 1956. Intense rainfall was recorded in the catchment (e.g. 185 mm on 21 January and 225 mm on 22 January 1956 at nearby Columba) and the river was in flood for about two months. The maximum recorded stream heights were 11.13 m in January and 8.76 m in February at Cunningham, located 60 km downstream. The nearby town of Texas was flooded and inhabitants could not cross the river for several weeks.

9. The failure of the Bonshaw Weir occurred during the overflow event. Both abutments failed. The left abutment was bypassed and it was heavily scoured. The right abutment and a section of the weir were washed away. The failure resulted from an average quality of construction and poor abutment foundations.

Fig. 3. Bonshaw Weir: (a) first Bonshaw Weir around 1953, view from downstream (courtesy of the Department of Natural Resources); (b) small overflow on 19 April 1955 (courtesy of the Department of Natural Resources); (c) view of the present weir from the left bank: note the ruins of the first weir downstream of the sheet pile cascade (photograph taken in February 1998)

10. In 1958, a new weir was built, at the same site, in steel sheet piles and concrete (Fig. 3(c)). Interestingly, the new weir is only 2.4 m high and it is shorter than the first weir.

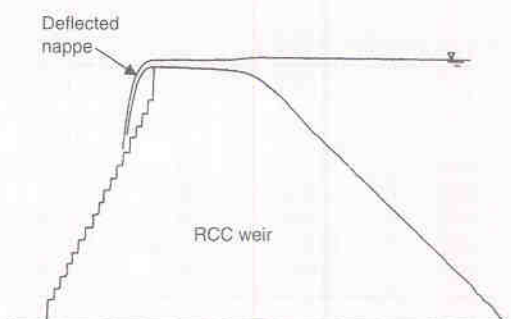
12. Completed in 1987, the Bucca Weir is a 12 m high RCC weir equipped with an overflow stepped spillway (Fig. 4). The design has a broad crest inclined upwards, followed by a 1.6 m drop and seventeen 0.6 m high steps ($h/l = 2$). The maximum design discharge is 7250 m³/s.

13. Shortly after completion, loud noises were heard during low overflows. At the brink of the first step (i.e. the downstream end of the crest), the water was deflected away from the chute as a free-falling nappe and the air cavity was not ventilated. Nappe instabilities developed and generated low-frequency vibrations in the structure and loud noises that were not acceptable to nearby residents. The problem was remedied by the installation of splitters on the crest edge to ventilate the nappe at low flows. The splitter devices are

Fig. 4. Bucca Weir spillway: low overflow (cross-section)

tiltable and drop at medium to large overflows.

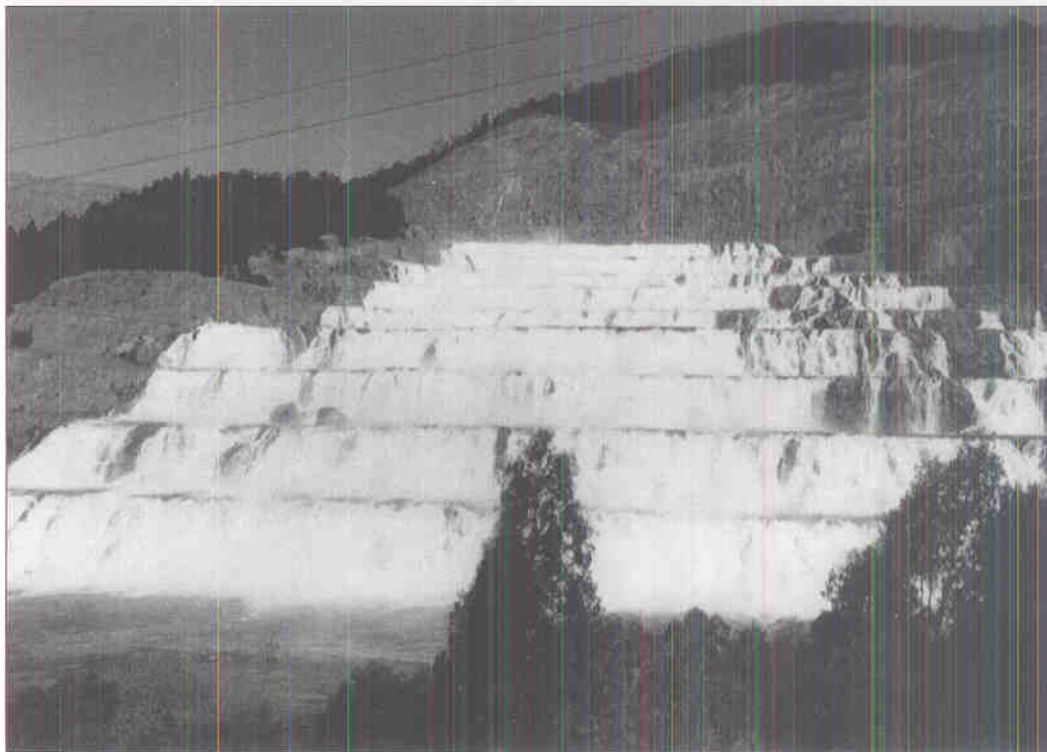
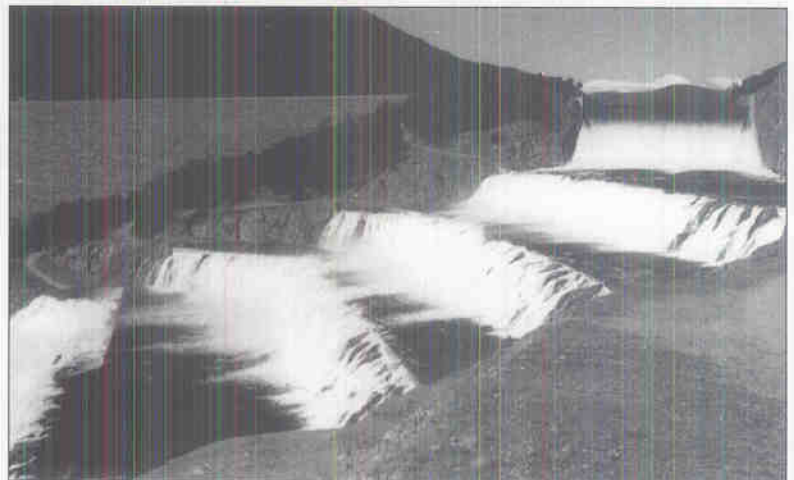
15. During the 1996 flood ($Q_w \approx 225 \text{ m}^3/\text{s}$), the unlined rock spillway was partially damaged. Although the discharge was much lower than the design flow rate, significant erosion was observed at several steps because of flow concentration in the right-hand side of the cascade.

Fig. 5. Dartmouth Dam spillway during the 1996 overflow ($Q_w \sim 225 \text{ m}^3/\text{s}$) (courtesy of Mr Jeffery, Goulburn-Murray Water): (a) spillway viewed from downstream: note the flow concentration in the middle of the photograph and the absence of flow on the right edge of the photograph; (b) details of the cascading flow from the left bank, showing the concrete-lined chute and the first steps

16. Repairs were undertaken in 1996 and 1997 that included the provision of shotcrete protection and the construction of anchored concrete retaining walls in the three upstream steps. Walls were built to prevent concentration of low-level flows in some areas.

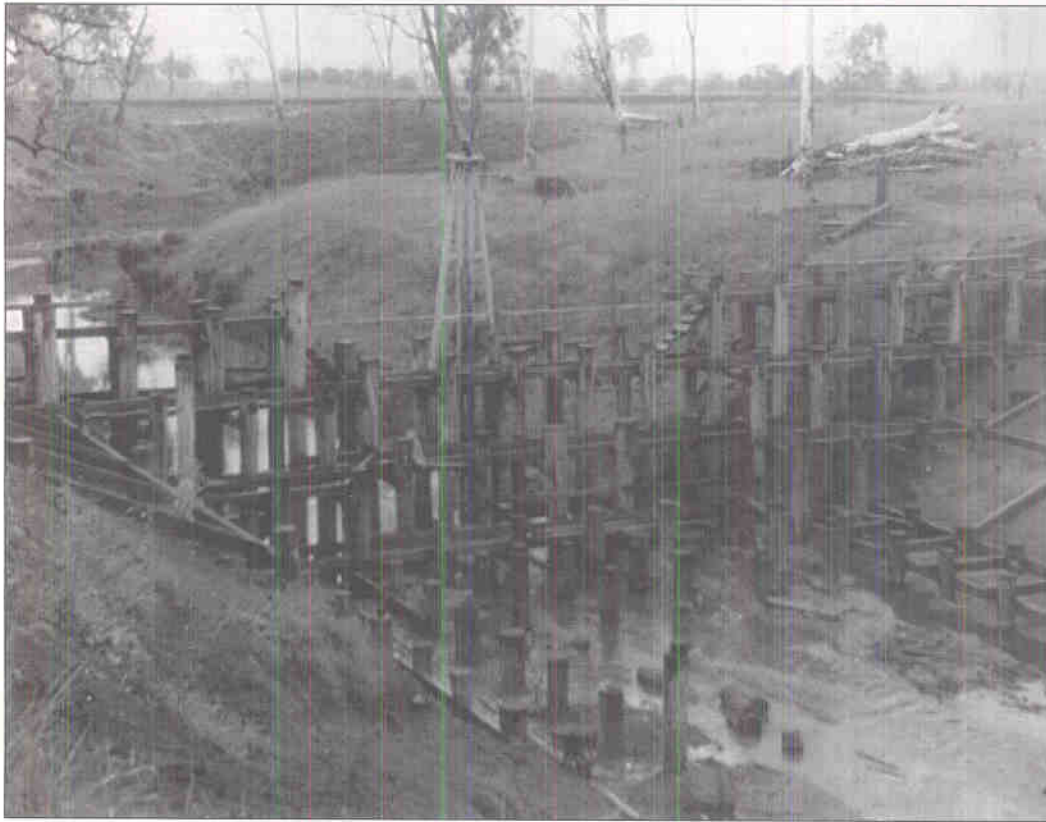
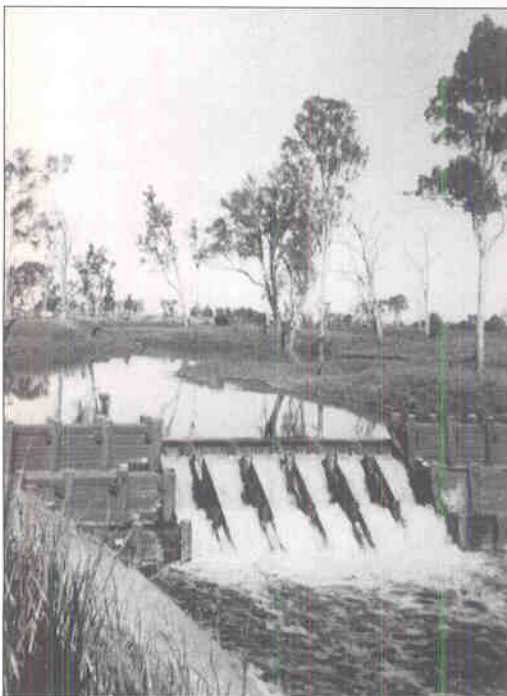
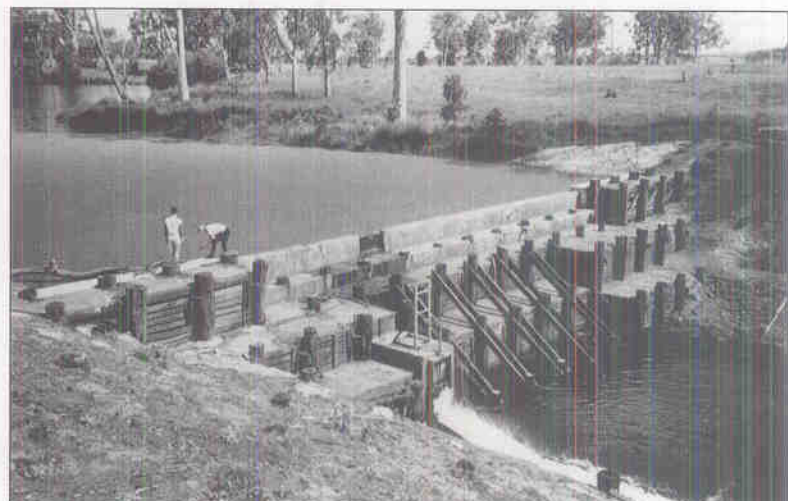
Fig. 6. Silverleaf Weir: (a) during construction in April 1952 (courtesy of Queensland Department of Natural Resources); (b) view from downstream right bank during a low overflow, shortly after completion (courtesy of Mr J. Mitchell); (c) refurbished weir viewed from left bank: the upstream concrete wall is clearly visible (photograph taken in November 1997)

31. The Silverleaf Weir was built between 1951 and 1953 for stock water. The 5.1 m high weir was designed as a timber crib piled weir with concrete protection of the four steps (Fig. 6). The upstream wall was sealed with a

32. During the refurbishment, an earthfill cofferdam was built 20 m upstream to dewater the weir. A flood event took place while the weir was dry and the clayfill was removed. The cofferdam was overtopped on 7 February 1995 and the resulting flood wave submerged the weir. The weir was overtopped by over 1 m of water and overtopping lasted for 24 h, with seepage through the timber cribs for a further 12 h before repairs could start. After the event, inspections showed that the weir sustained the flood wave without major damage. The overtopping was filmed and the document highlighted the good stability of the structure, the significant energy dissipation during large overflow and the seepage through the rockfill material during the receding flood surge.

33. The Silverleaf Weir refurbishment was completed as planned and the weir is still in use (Fig. 6(c)). Overall, the experience suggests that the timber weir design was sound and the structure is very stable despite its age.

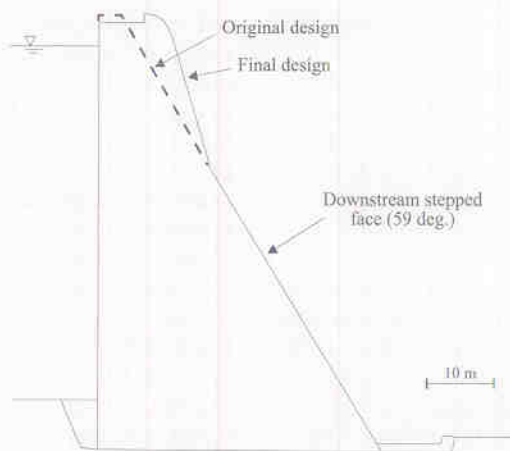
Fig. 7. Cross-section of the Upper Stillwater Dam spillway
