# Environmental fluid mechanics of minimum energy loss weirs: hydrodynamics and self-aeration at Chinchilla MEL weir during the November–December 2021 flood event

Hubert Chanson<sup>1</sup> · Colin J. Apelt<sup>1</sup>

**Keywords** Minimum energy loss (MEL) weir design · Field measurements · Self-aeration · Surface velocity field · November/December 2021 flood · Optical flow (OF)

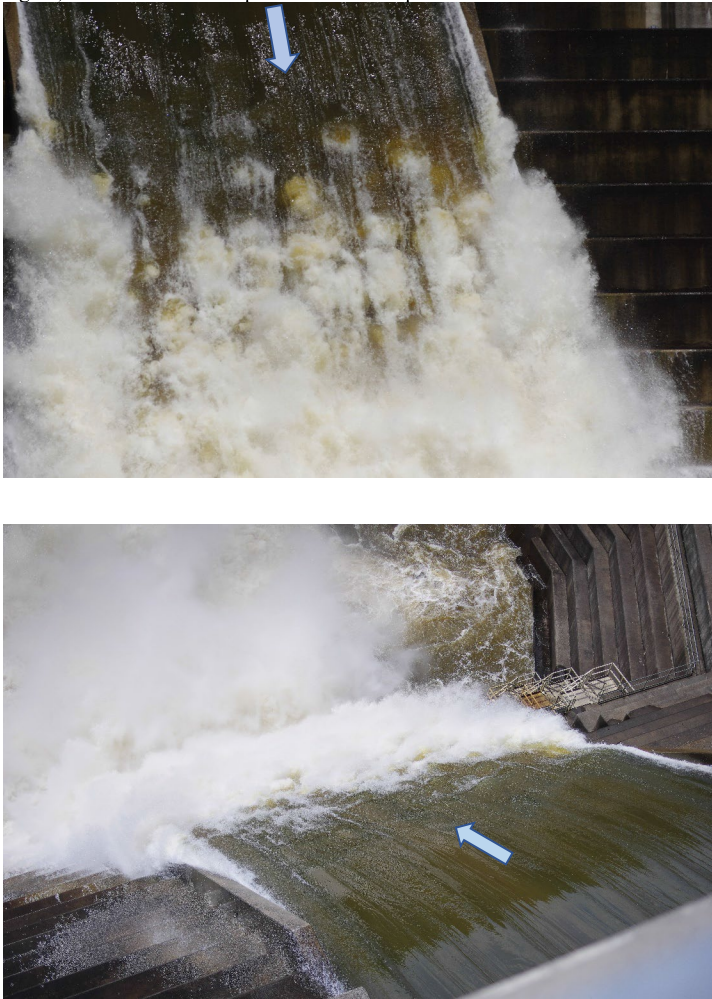
**Fig. 1** Onset of self-aeration on overflow spillways

(A) Inception region on a steep chute: Hinze Dam Stage 3 spillway (Australia) on 24 March 2021 ( $\theta = 45.9^\circ$  [at inception],  $Re = 5.6 \times 10^7$ , Shutter speed:  $1/8,000$  s) - Top: view from downstream of the inception region; Bottom: view from upstream of the inception - Arrows indicate the main flow direction

In most overflow spillways, the upstream flow region is brown and non-aerated, and a strong air–water mixture develops downstream of the onset region of air entrainment [30, 37]. At the upstream end of the spillway, the flow is accelerated in a relatively smooth manner [29, 36]. A turbulent boundary layer develops along the invert from the upstream end [32, 34]. On a steep overflow spillway, the inception of free-surface aeration typically occurs when the outer edge of the bottom boundary layer starts to interfere with the water surface [31, 36, 50]. The interactions between boundary layer turbulence and free-surface can be explosive accompanied by strong projections of air–water packets [16, 21, 57]. In contrast, on a flat chute, the onset region exhibits a free surface with the gradual development of small ripple and surface instabilities, and the water surface tends to present a choppy appearance when self-aeration starts to occur [11, 12, 46]. Levi [40, 41] and Anwar [1] argued that the inception conditions then combine the effects of longitudinal vortices' breakdown and of gravity waves produced by boundary irregularities and roughness. Recently, Toro et al. [54] and Chanson [19, 21] demonstrated that the two theories are not exclusive using two different approaches. That is, three-dimensional Computational Fluid Dynamics (CFD) computations [54] and detailed prototype observations [19, 21] respectively. The inception region of free-surface aeration is illustrated on two prototype spillways in Fig. 1, using high-shutter speed (1/8000 s) photographs of the onset region in relatively steep and flat overflow chutes, i.e. Figure 1A, B respectively. The location of both structures is shown in Fig. 2.

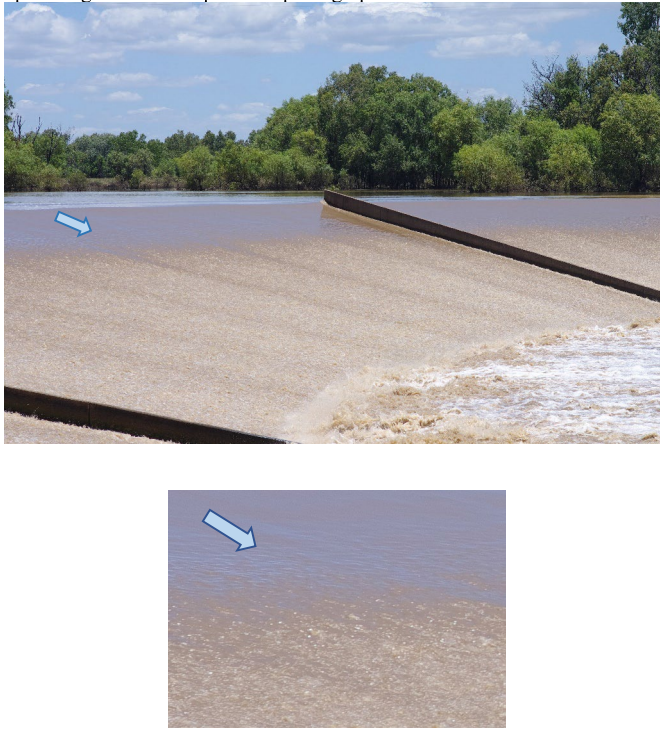
**Fig. 1** (continued)

(B) Inception region on a flat chute: Chinchilla MEL weir (Australia) on 27 November 2021 ( $\theta = 11.3^\circ$ ,  $Re = 2.3 \times 10^6$  [at inception], Shutter speed: 1/8,000) - Top: General view from the right bank; Bottom: details of inception region from the previous photograph - Arrows indicate the main flow direction

The Chinchilla minimum energy loss weir (QLD, Australia) (Figs. 1B, 5) is located in the Western Downs, along the Condamine River to provide both town and irrigation water supply [49]. The longitudinal river bed slope is  $S_o = 0.215\%$  in average between Brigalow and Chinchilla weir. Completed in 1973, the weir provides irrigation water, and it is listed as a "large dam". With a catchment area of 19,192 km<sup>2</sup>, the weir is a 14 m high earth fill embankment with a 410 m long dam crest including abutments. The overflow spillway (Fig. 1B) has a design capacity is of 850 m<sup>3</sup>/s corresponding to bank full at a design head 1.83 m. The spillway system consists of a broad crest that is 214 m long, followed by a smooth converging chute with a 1 V:5H slope. There is no stilling basin. After completion, grass was planted in the top soil and protective mesh that had been placed on the subsidiary earth embankments on each bank. Before this had time to grow, the weir was subjected to a major out-of-bank flood of order 1,130 m<sup>3</sup>/s, one of the highest on record, and that overtopped the embankments [55]. At the peak of the flood, it was difficult to see where the weir was, because it was completely drowned out. As the flood receded, it was wonderful to see the structure emerge from the flood waters relatively unscathed. The top soil and grass planted over the plastic mesh and gravel on the top of these embankments were washed away for the most part, but the mesh

Based upon the video movies of the left chute centreline, taken from downstream, the surface velocity field was measured in the plane parallel to the invert using the optical flow (OF) technique. Both the streamwise velocity  $V_s$  and transverse velocity  $V_t$  components were extracted. First, the present data provided physically meaningless results in the upstream non-aerated flow region. This was most likely caused by the shiny surface glare, seen in Figs. 1B and 6, upstream of the inception region. Second, physically meaningful

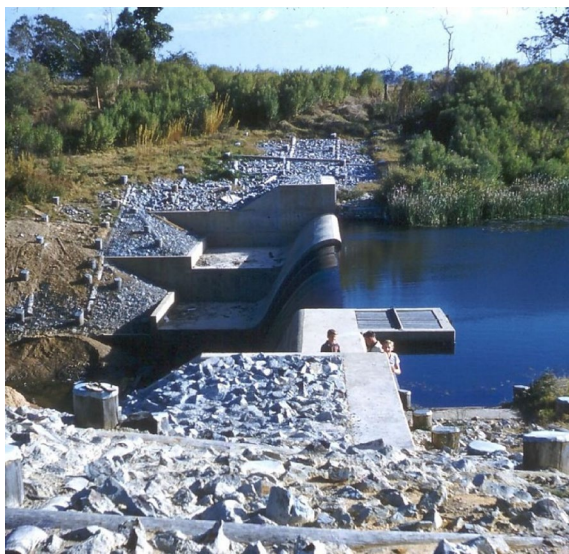
**Fig. 3** In-stream weir on Wararba Creek weir near Caboolture (Australia) in the 1960s (Photographer Roy Dobson. Image courtesy of Moreton Bay Regional Council, reference number CLPC-P2299)

scour protection for the embankments to prevent scour there. An example of such a design is the weir on Wararba Creek near Caboolture, Queensland, Eastern Australia (Fig. 3). However, eventually it proved impossible to develop a satisfactory design based on these principles for the site on Sandy Creek, despite a large number of attempts. The competing requirements for this weir and for many others constructed in streams with erodible banks are: (1) maximum in-stream storage, (2) protection against erosion of the stream banks at the abutments of the weir and downstream and (3) no increase in the frequency of out-of-bank flooding. The conventional type of weir caused excessive afflux and over-bank flow and massive erosion of the alluvial banks at the abutments and downstream, even for flows considerably less than the design flow. When Apelt [4] was invited to observe the performance of the last of these unsatisfactory model tests, it was clear that the weir was causing too much constriction of the flow with large energy losses. He noted that the flow over the weir was analogous to that past an orifice plate in a pipe and suggested an approach analogous to a Venturi tube. The idea was to minimise the energy loss across the structure by using a more streamlined geometry everywhere and a gradual expansion downstream to recover as much as possible of the kinetic energy of the flow at the weir crest. A large number of trials finally produced a satisfactory design for the site on Sandy Creek, Clermont and the first MEL weir was built there in 1962 (Fig. 4) [4].

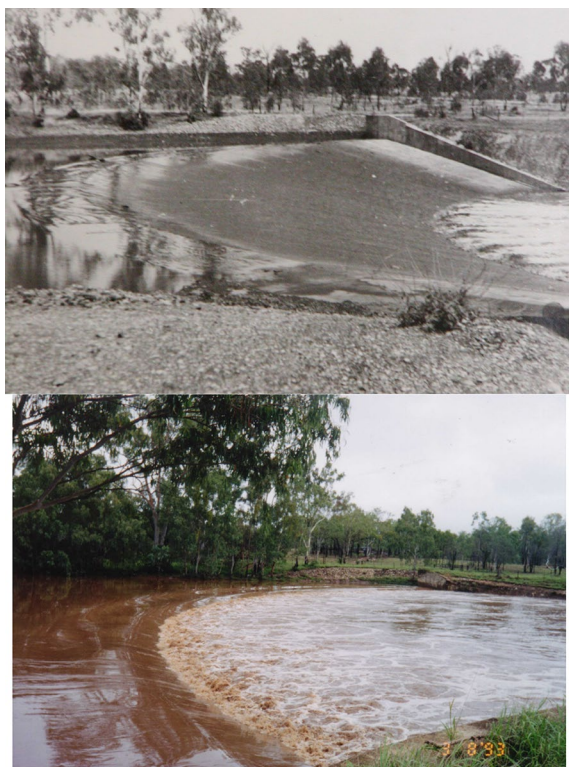
**Fig. 4** Sandy Creek MEL weir at Clermont—Top: discharging a small flow about 142 m<sup>3</sup>/s (Collection of late Professor G.R. McKay); Bottom: large flood event on 3 August 1993 (Courtesy of A.J. Holmes)

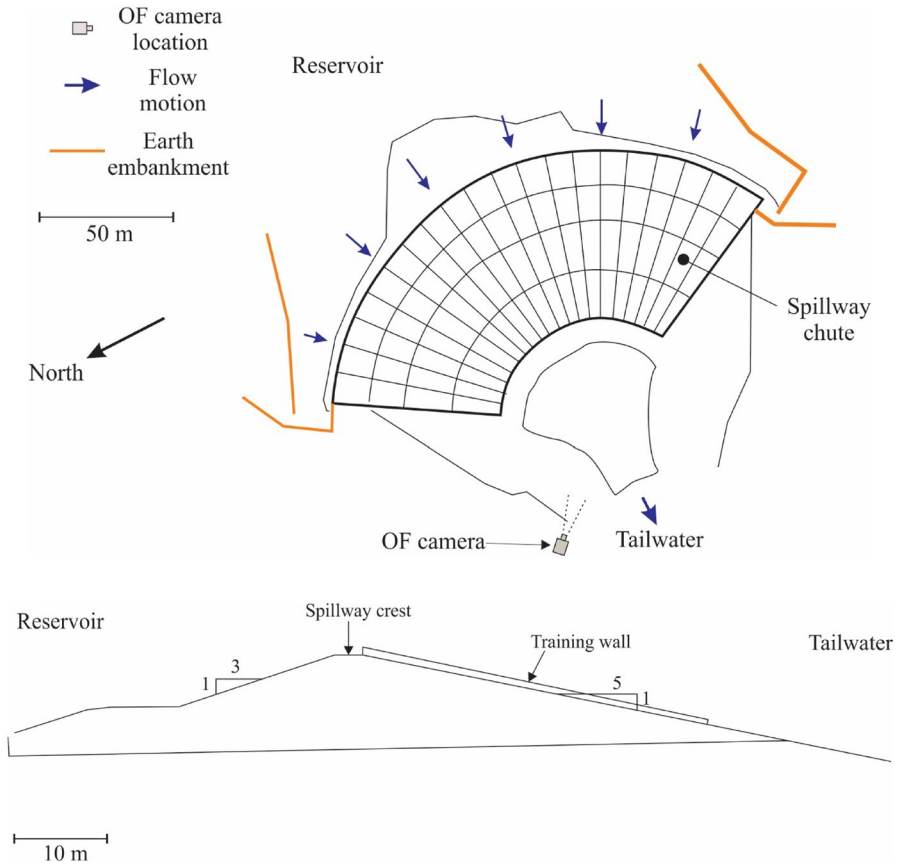
**Fig. 5** Plan view and cross-section of Chinchilla MEL weir (redrawn after [55])

from the weir crest are excavated sufficiently to provide for efficient flow normal to the crest, uniformly distributed along its full length. Figure 5, based on the design drawings of the Chinchilla MEL weir, illustrates these principles.

The water discharge was deduced from the measured reservoir elevation, using the predicted discharge coefficient, based upon the drawings as constructed (Fig. 5) [33]. Visual, photographic and cinematographic records were undertaken from the right bank of the spillway and from the right river bank downstream of the spillway toe. Figures 1B and 6 present hand-held photographs taken from several locations. The observations were conducted using three dSLR Pentax™ cameras with sensor resolutions between 12 and 24 Mpx, a digital camera Sony™ RC100VA and an iPhone XI. The dSLR cameras were equipped with full-frame prime lenses producing photographs and movies with negligible barrel distortion. The dSLR camera movies were recorded in high definition (1920 × 1080 px) at 30 fps and 60 fps.

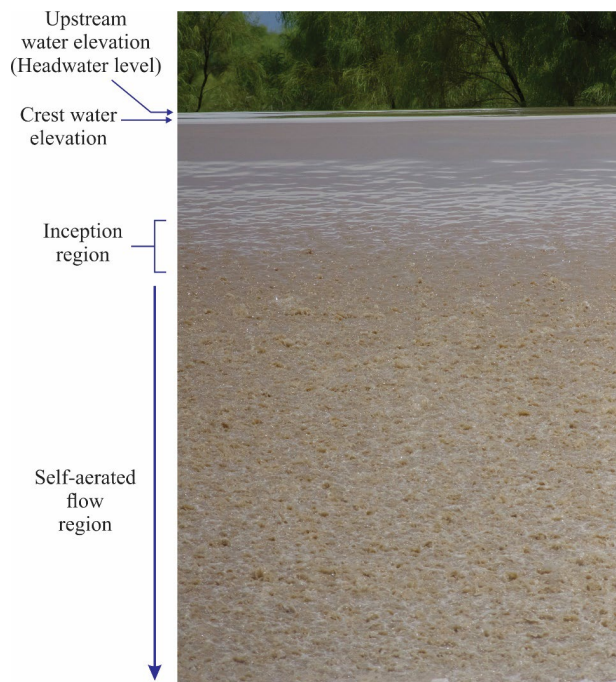
(A) Upstream flow viewed from downstream on 27 November 2021 (Shutter speed: 1/8,000 s) - View of the left spillway chute from the OF camera shown in Figure 5A

**Fig. 6** Photographs of the spillway operation at Chinchilla MEL weir (QLD, Australia) during the major flood in Nov./Dec. 2021

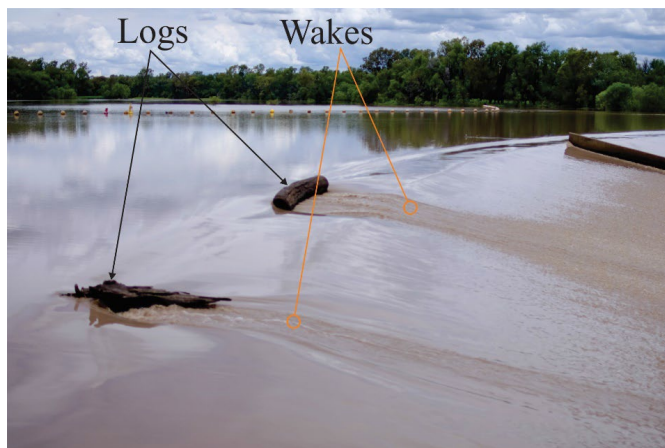
(B) Timber logs blocked at the spillway crest on 27 November 2021 (Shutter speed: 1/8,000 s)

On both occasions (Table 2), the approach flow was very smooth, and this was confirmed by aerial footages on 21 December 2018 and on 3 December 2021. The reservoir flow converged smoothly towards the weir crest and the water surface was waveless and almost still. On both 27 November 2021 and 15 December 2021, the flow was critical at the spillway crest which acted as a broad-crested weir, with a ratio of crest length to upstream head over crest of 6.2 and 5.54 respectively. The smooth change on water surface elevation between the upstream reservoir and spillway crest was nicely documented with photographs (Fig. 6A). Immediately downstream of the broad-crest, the water surface was smooth and glassy (Figs. 1B, 6). On 27 November 2021, a few logs were trapped at the crest, and their wake was clearly seen at the surface of the non-aerated flow. Further downstream, the wake progressively disappeared in the self-aerated air–water flow region (Fig. 6B).

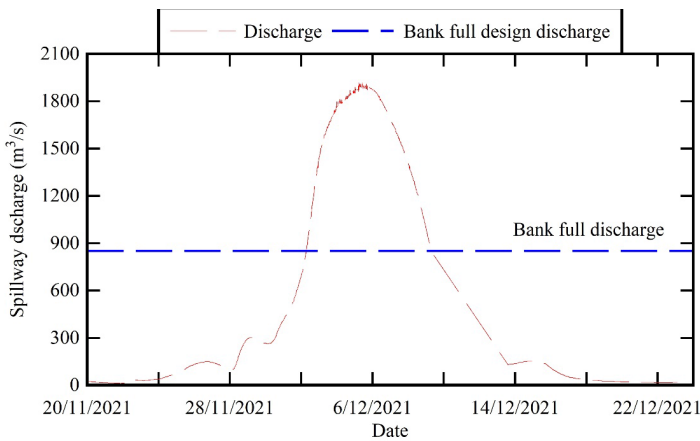
(A) Water discharge over the spillway excluding the abutment overflows

The Chinchilla weir overflow was documented on 27 November 2021 and 15 December 2021. The first data set was obtained at the start of the flood event, while the second took place after the peak of the flood (Fig. 7). The flow conditions at the time of observations are detailed in Table 2. Note that the weir overflow could not be witnessed at the peak of the flood by the authors, because the access road become submerged when the tailwater elevation exceeds about 290–291 m AHD. The afflux, difference between recorded High Water Rating Level (HWRL) and Tailwater Rating Level (TWRL), was 3.23 m at the peak of the flood event (Fig. 7B), which was somewhat consistent with some photographic observation by a local on 5 December 2021 morning. The maximum tailwater elevation and afflux during the 2021 flood event is compared with several documented major floods, including several major floods in 2022 in Table 1.

**Fig. 7** Spillway operation at Chinchilla MEL weir (QLD, Australia) during the major flood in Nov./Dec. 2021: water discharge over the spillway and afflux

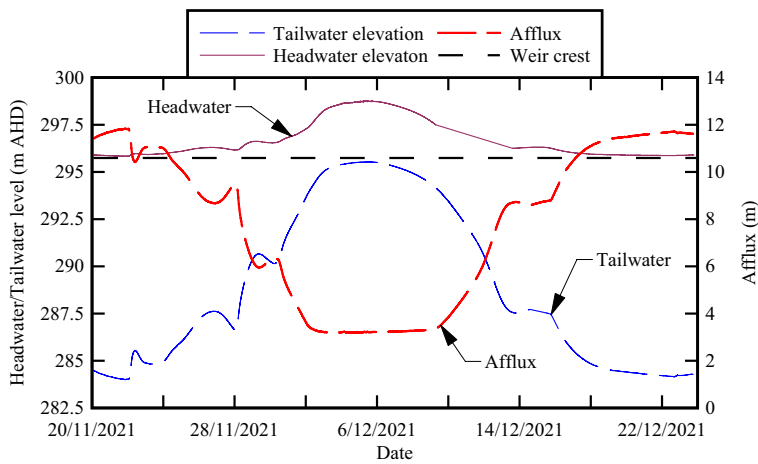
(B) Measured headwater levels, tailwater levels and afflux - the afflux being defined as the difference between the headwater level (H.W.L) and tailwater level (T.W.L.)

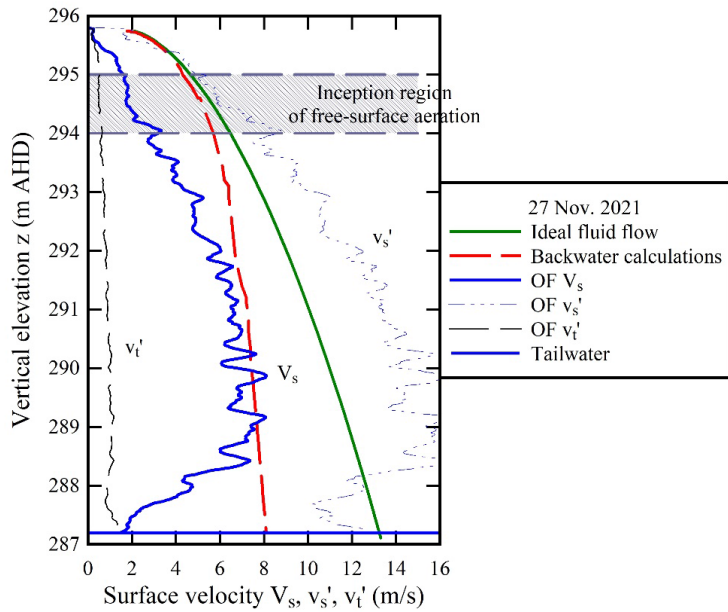
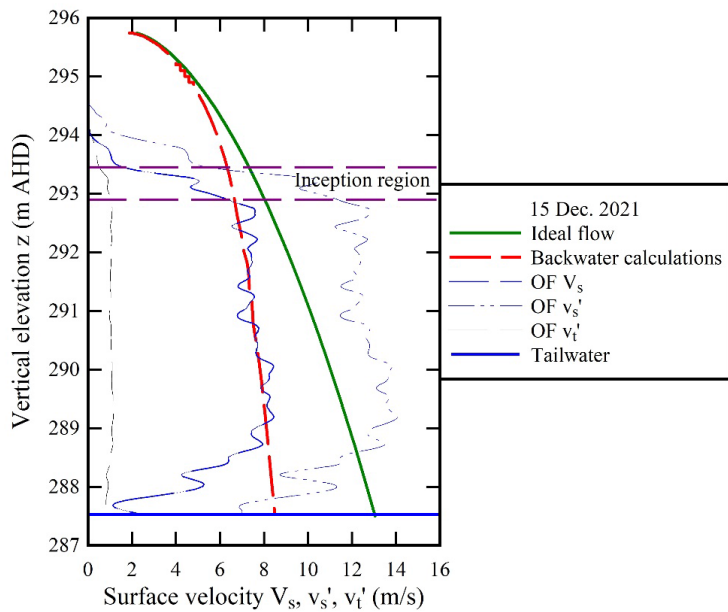
(A) On 27 November 2022 ( $Q = 121 \text{ m}^3/\text{s}$ )

(B) On 15 December 2022 ( $Q = 144 \text{ m}^3/\text{s}$ )

**Fig. 8** Time-averaged OF surface velocity: comparison between time-averaged optical flow (OF) surface velocity data, ideal fluid flow velocity and backwater calculations at Chinchilla MEL weir

The surface velocity data showed a relatively close agreement between the time-averaged streamwise OF surface velocity and the backwater-calculated velocity downstream of the onset region, both qualitatively and quantitatively (Fig. 8). Figure 8 presents some typical comparisons in terms of streamwise surface velocity component  $V_s$ , with each graph corresponding to one movie. In Fig. 8, the ideal fluid flow estimates are shown with a solid green curve and the backwater calculations are the dashed red curve. For completeness, the streamwise surface velocity standard deviation  $v_s'$  and transverse surface velocity standard deviation  $v_t'$  are added in Fig. 8. In Fig. 8, the vertical axis is the vertical elevation in m AHD, where AHD stands for Australian Height Datum, and the horizontal axis is the surface velocity data in a dimensional form.

The time-averaged OF surface velocity data presented a number of key features. Firstly, the time-averaged longitudinal velocity component increased with decreasing vertical elevation, as it would be physically expected (Fig. 8). Secondly, the longitudinal velocity data showed some poor agreement with ideal fluid velocity estimates in the developing non-aerated flow region. For  $z_o > 294$  m AHD, the poor results were caused by the water surface reflections, seen in Figs. 1A and 6, preventing the OF technique to track the flow motion based upon the brightness intensity gradient. Thirdly, the time-averaged OF velocity data agreed relatively well with the backwater calculations developed for the converging chute (see above) and valid in the fully-developed self-aerated flow region.

The comparison reflects well the adequacy of the backwater calculations assuming a gradually-varied chute flow. While the method was herein applied to the self-aerated flow region, drag reduction caused by self-aeration was not expected to occur for this flat slope (1 V:5H), because of the small values of mean void fraction down the chute slope, with nil to negligible effect on the friction factor, even if quasi uniform air–water flow would be attained (e.g. as per [12]). At the downstream end of the chute, i.e. for  $z_0 < 288$  m AHD, a lack of match with backwater estimate might be caused by optical artifacts caused by spray and splashing above the hydraulic jump roller at the chute toe. Indeed, visual observations by the first author showed drops and splash reaching heights of more than 0.5–1 m above the hydraulic jump roller surface. Fourthly, the OF data output quality was closely linked to the quality of the original movies. Practical considerations encompassed the camera position, ideally placed perpendicularly to the spillway chute, a sturdy camera tripod, and the camera body and lens equipment, with all the present data set acquired with professional-grade full-frame prime lenses, following earlier experiences [6, 19, 21]. More, a higher movie definition delivered improved outputs with greater spatial resolutions, i.e. less millimetres per pixel. It is worth to mention that both OF field data sets were filmed under good weather conditions, hence decent lighting conditions.

As seen in Figs. 8, 9 and 10, the results were unreliable in the upstream non-aerated flow. Further, the surface velocity data were not reliable below elevation 288 m AHD, because of the splashing above the hydraulic jump roller. In the self-aerated flow region, the surface velocity data implied some regions of high-velocity and others of low-velocity. That is, longitudinal "canyons" of faster flowing water, with streaks of lower surface velocities in between, in the self-aerated flow region downstream of the inception region. The same data sets highlighted regions of high- and low-streamwise velocity fluctuations. The observations were similar to recent field observations at the Hinze Dam Stage 3 [19, 21] and in a relatively large-size spillway model [6]. The findings are important in terms of the design and operation of energy dissipators, e.g. hydraulic jump stilling basins and ski jumps. Indeed, these regions of high velocity are associated with concentrations in kinetic energy that must be dissipated safely in the stilling structure.

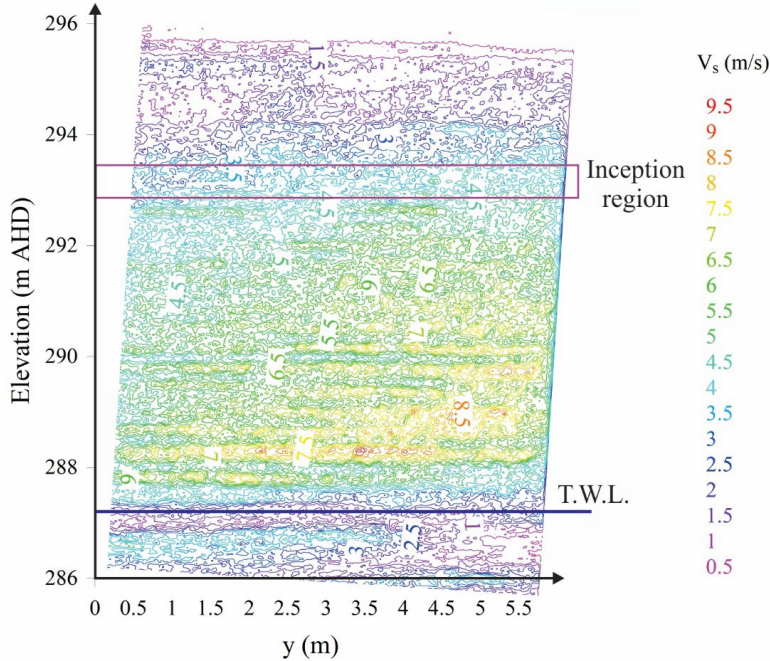
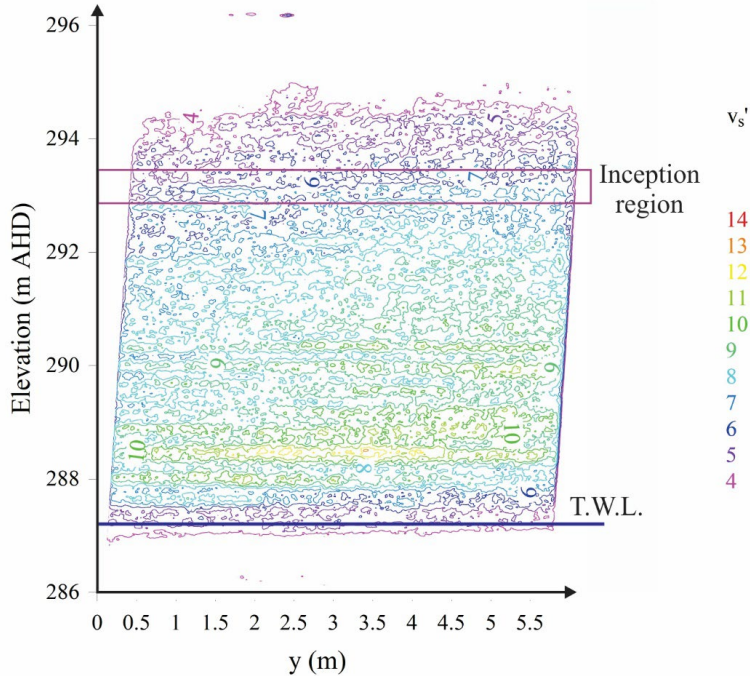
**Fig. 9** Contour map of time-averaged surface velocity and standard deviation of longitudinal velocity at Chinchilla (MEL) weir on 27 November 2021—Location: middle of left spillway bay, Time: 14:18, Number of analysed frames: 840, Resolution: 0.00515 m/px, Frame rate: 30 fps. **A** Time-averaged longitudinal surface velocity. **B** Standard deviation of longitudinal surface velocity

(A) Time-averaged longitudinal surface velocity

(B) Standard deviation of longitudinal surface velocity

The OF surface velocity characteristics were analysed in the self-aerated flow region, in terms of the contour maps of time-averaged longitudinal velocity component, standard deviations of the longitudinal and transverse surface velocity. Typical contour maps of the time-averaged longitudinal velocity component  $V_s$  and standard deviations  $v_s'$  of the longitudinal surface velocity are shown in Figs. 9 and 10. In Figs. 9 and 10, the horizontal axis is a transverse coordinate, the vertical axis is the vertical elevation in m AHD, and the contour data are the velocity data measured parallel to the invert. The legend on the right of Figs. 9 and 10 explains the colour coding of the contour maps. In the contour maps, the tailwater level is shown as well.
