Discussion of “Cavitation Potential of Flow on Stepped Spillways” by K. Warren Frizell, Floriana M. Renna, and Jorge Matos

Hubert Chanson¹

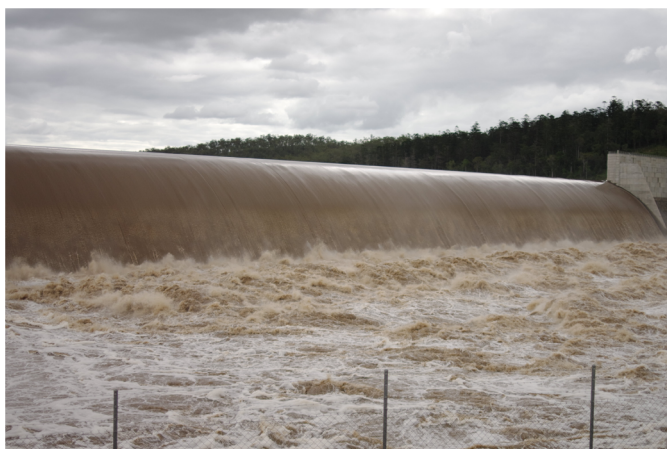
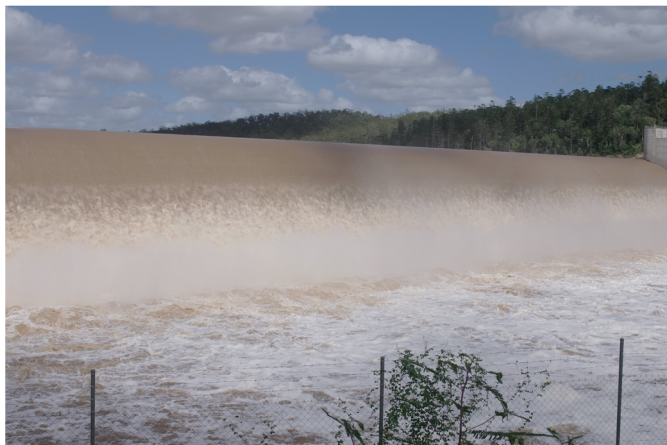
Fig. 1. Paradise Dam stepped spillway (Australia) in operation (spillway geometry: $\alpha = 57.4^\circ$, $h = 0.62$ m, RCC structure): (a) $q = 19$ m²/s on December 30, 2010 (shutter speed: 1/8,000 s); (b) $q = 7.4$ m²/s on March 5, 2013 (shutter speed: 1/1,600 s)

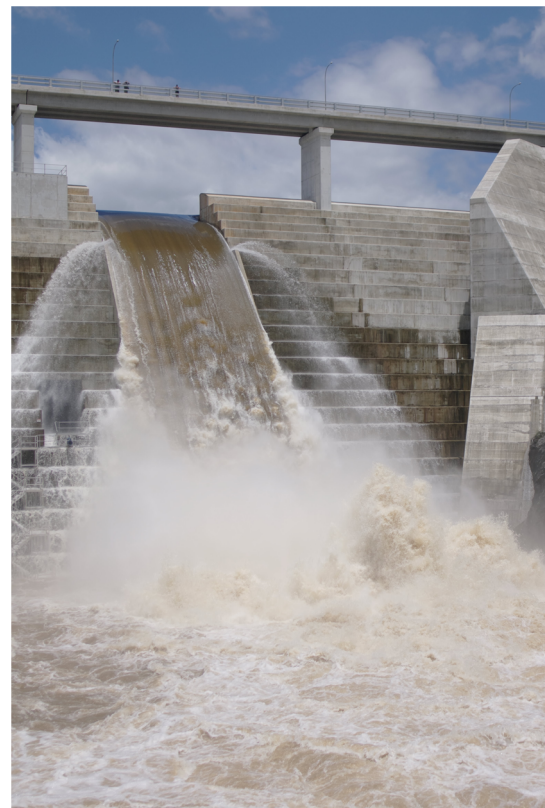
Fig. 2. Hinze Dam stepped spillway (Australia) in operation (spillway geometry: $\alpha = 51.3^\circ$, $h = 1.2$ m, rockfill dam wall with conventional concrete spillway): view from downstream for $q = 14$ m²/s on January 29, 2013 (shutter speed: 1/8,000 s)
