Discussion of “Overtopping Breaching of Noncohesive Homogeneous Embankments” by Stephen E. Coleman, Darryl P. Andrews, and M. Grant Webby

September 2002, Vol. 128, No. 9, pp. 829–838.
DOI: 10.1061/(ASCE)0733-9429(2002)128:9(829)

Closure to “Overtopping Breaching of Noncohesive Homogeneous Embankments” by Stephen E. Coleman, Darryl P. Andrews, and M. Grant Webby

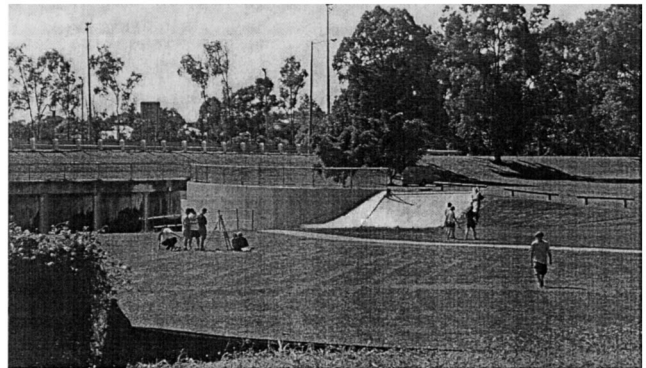
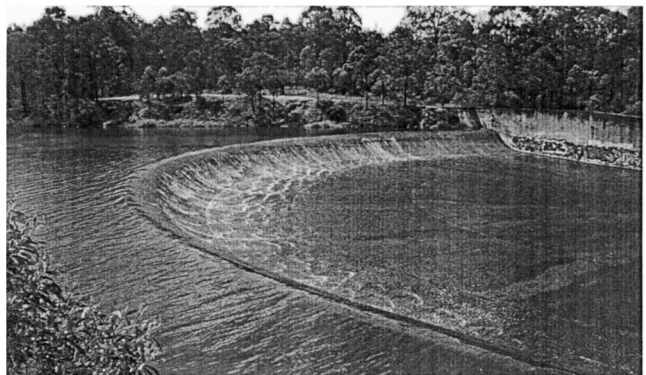
Fig. 1. Examples of minimum energy loss inlets. (a) Minimum energy loss culvert in Brisbane during some undergraduate student field work on May 13, 2002. Culvert completion, 1975; throat width=7×2 m; barrel height=3.5 m; design flow, 220 m³/s (Chanson 1999, pp. 383 and 425) and (b) minimum energy loss spillway inlet at Lake Kurwongbah (Sideling Creek Dam), Brisbane, Australia on Sept. 12, 1999. Completed in 1969; $H=25$ m; reservoir capacity, 15.5 Mm³; design flow, 710 m³/s.

The discussor congratulates the authors for their authoritative work. Their observations of breach crest curve and streamline pattern in the breach show a challenging similarity with the inlet designs of minimum energy loss (MEL) culvert and weirs on which the discussor will expand. Fig. 1 illustrates two proven designs that have operated successfully for over 30 years. Earlier, McKay discussed the similarity with natural scour: “It became obvious that the forms required [for the MEL design] were common natural shapes,” “one natural occurrence is the inevitable bar at the mouth of an alluvial river” while “the same shape occurs in the scour holes below restrictive bridges, culverts and even pipes” (McKay 1970, p. 10). Visser et al. (1990) conducted a prototype experiment with a 2.2-m-high dyke breached during rising tide. Photographs of the breach profile illustrated an hourglass profile similar to the authors’ observations and to minimum energy-loss structures. Gordon (1981) filmed lagoon breakouts at Dee Why, illustrating well the hourglass shape. His field measurements showed that the breach width reached up to 67 m for a 150 m³/s final breach flow.

bed slope. The first MEL weir was the Clermont weir built in Queensland, Australia in 1962. The largest, the Chinchilla weir built in Queensland in 1973, is listed as a “large dam” by the International Commission on Large Dams. Fig. 1(b) shows the MEL inlet of the Lake Kurwongbah spillway, designed in a fashion somewhat similar to a MEL culvert inlet (McKay 1971). The crest inlet fan converges into a 30.48-m-wide channel ending with a small flip bucket. The MEL crest design allowed an extra 0.4572 m of water storage.

A MEL weir is typically curved in plan with converging chute sidewalls, and the overflow spillway chute is relatively flat [Fig. 1(b)]. The downstream energy dissipator is concentrated near the channel centerline away from the banks. The inflow Froude number remains low, and the rate of energy dissipation is small compared to a traditional weir. For example, the Chinchilla weir was designed to give no afflux at its designed flow (850 m³/s). In 1974, it passed 1,130 m³/s with a measured afflux of less than 100 mm (Turnbull and McKay 1974).

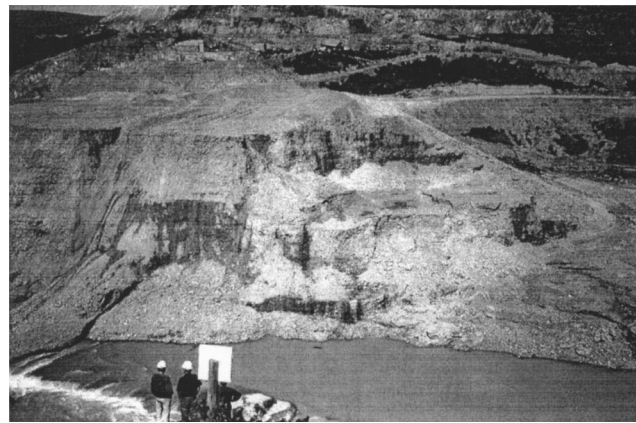
Fig. 2. View from left abutment looking across breach in Opuha Dam toward remaining part of embankment

foreground. The left side of the breach was formed by natural country on the left abutment of the dam while the right side was formed by exposed fill material. Fig. 2 here shows a view across the breach from the left abutment of the dam. This illustrates the zoned structure of the embankment forming the dam and the shape of the upstream end of the breach channel. Fig. 3 here shows a view of the breach looking downstream from a similar location to Fig. 2. The dam outlet pipe (which also acted as the diversion facility during construction) leading to the buried circular powerhouse is visible in the base of the breach channel.

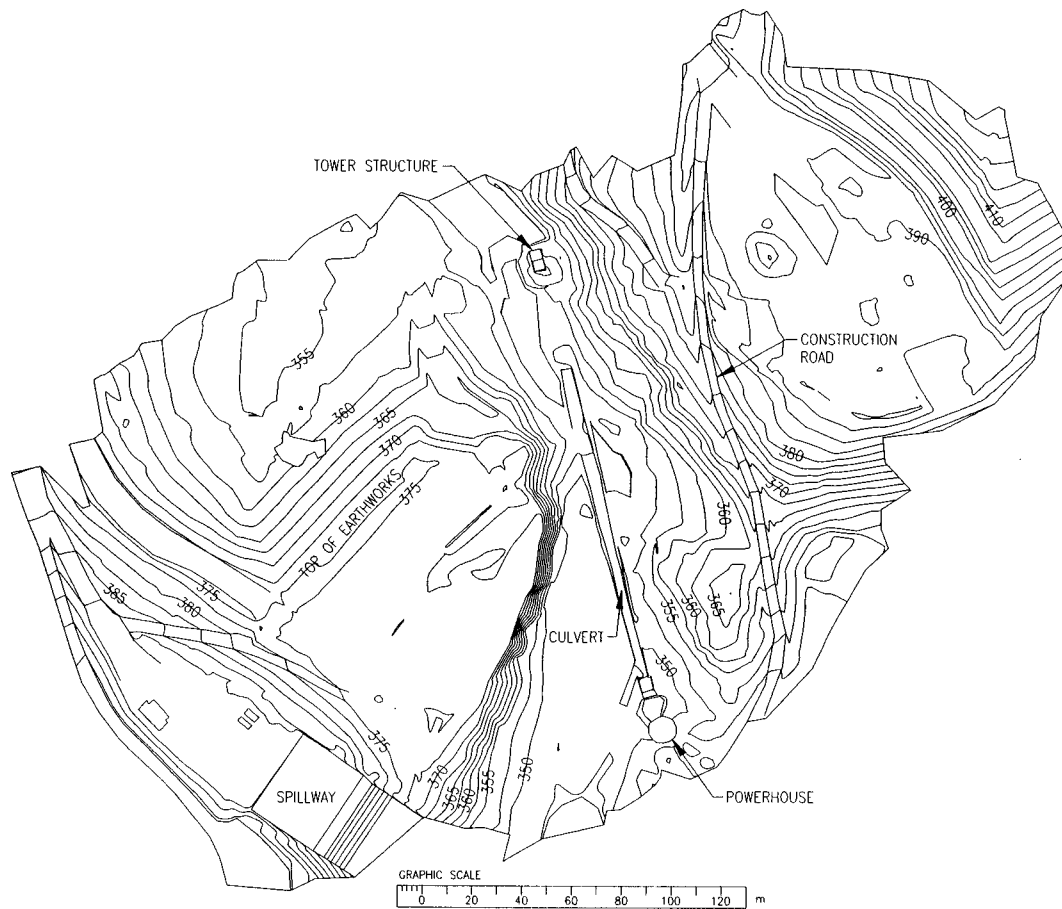
Fig. 4. Topographic contour plan of breached Opuha Dam immediately following dam failure

Fig. 4 here shows a postfailure contour plan of the breached dam with contours at 2.5 m spacing. The shape of the breach channel evident in this plan can be compared with the breach channel shapes observed from the laboratory experiments of model dams formed from noncohesive materials, as evidenced in the present paper (Coleman et al. 1997; Andrews et al. 1999). The comparison is strictly only valid for the right side of the breach of the Opuha Dam embankment, as the left side was formed by natural country on the left abutment of the dam.

Fig. 4 indicates some rounding of the contours at the upstream end of the right side of the prototype breach channel. However, this rounding is much less accentuated than that observed in breach channels from model-dam experiments and those featured

in MEL structures. The breach channels in the model-dam experiments were formed for a constant-level reservoir. The writers consider that the less rounded nature of the upstream end of the prototype breach channel was primarily attributable to the falling level of the upstream reservoir during the course of breach development. The prototype breach channel appeared to be oriented at a slight angle to the main along-valley axis of the dam, and this would have contributed to the rounding of the channel side on the right at the downstream end of the breach channel. The material forming the right side of the prototype breach channel at the downstream end stood quite steeply.
