RESERVOIR SEDIMENTATION IN AUSTRALIA UNDER EXTREME CONDITIONS

Hubert Chanson
School of Civil Engineering, The University of Queensland, Brisbane, QLD, Australia

ENCYCLOPEDIA *of* LAKES AND RESERVOIRS

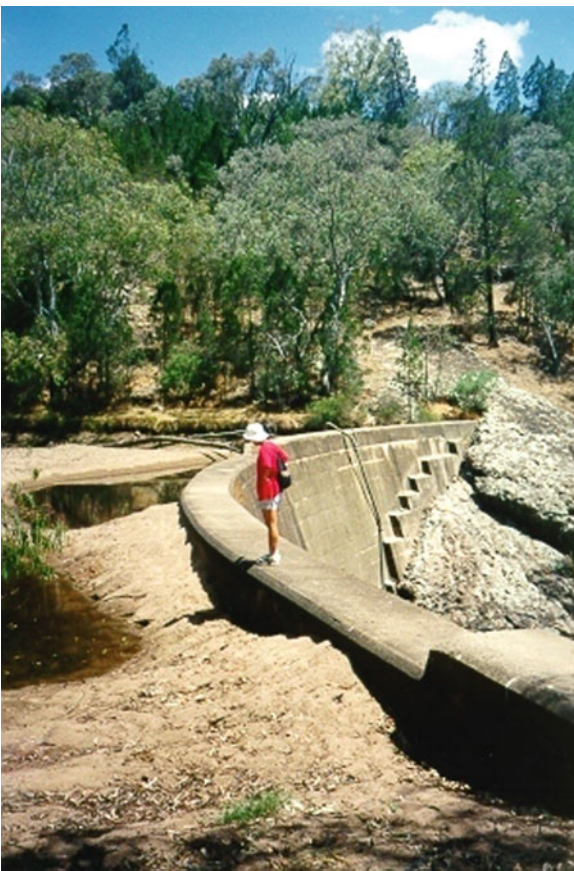
Reservoir Sedimentation in Australia under Extreme Conditions, Figure 2 Dry reservoir of Koorawatha weir, railway dam completed in 1911 – view from the right bank in December 1997.

The Koorawatha dams, located near Koorawatha NSW, were a railway dams, designed to supply water to the steam engines for the nearby railway line, opened in November 1886 and closed in 1980. Two thin-arch concrete dams were built successively at the same site. The first dam was 5–7 m high, and it is located 5–10 m upstream of the present dam (Figure 2). The crest was still

visible during dry periods up to the 1930s although, today, it is underneath the dry reservoir bed. Completed in 1911 (or 1913?), the second Koorawatha dam is a concrete single-radius arch (9 m high, 0.92 m thick at crest, 40-m arch radius). The upstream wall is vertical, and the downstream face is battered. The weir was equipped with an outlet system and an overfall spillway (24 m long, 0.3 m high). The reservoir is fully silted today, occupied by sand and gravels, suggesting sedimentation by bed-load (Figure 2).

The fully silted reservoirs stand as a source of embarrassment for the scientists and the public (Figures 2–5). Each reservoir failure must be a valuable teaching and pedagogic tool to heighten the awareness of students, professionals and local authorities, and of the public. Society must learn from its mistakes, not to repeat them again!

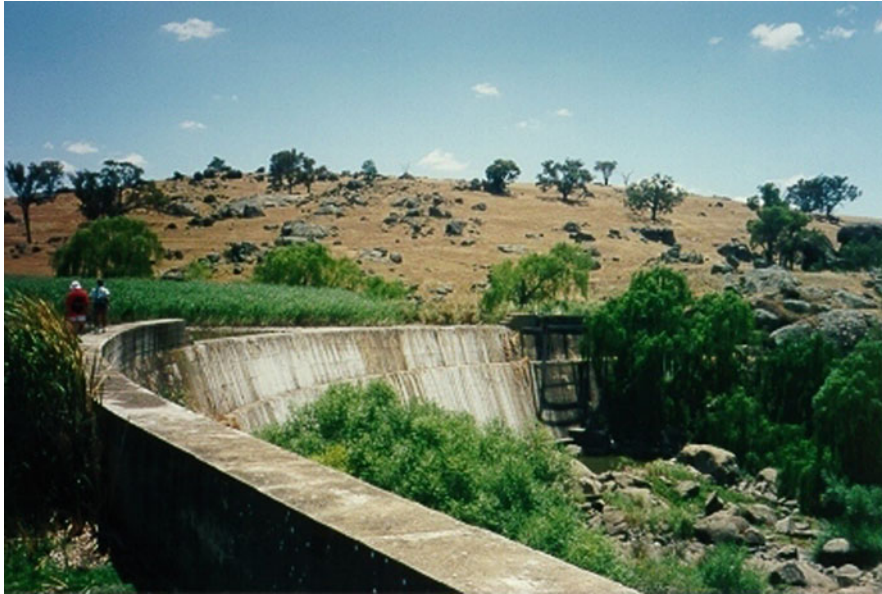
Reservoir Sedimentation in Australia under Extreme Conditions, Figure 3 Fully silted reservoir of Cunningham Creek railway dam (Harden NSW) completed in 1912 – view from the right bank in December 1997.

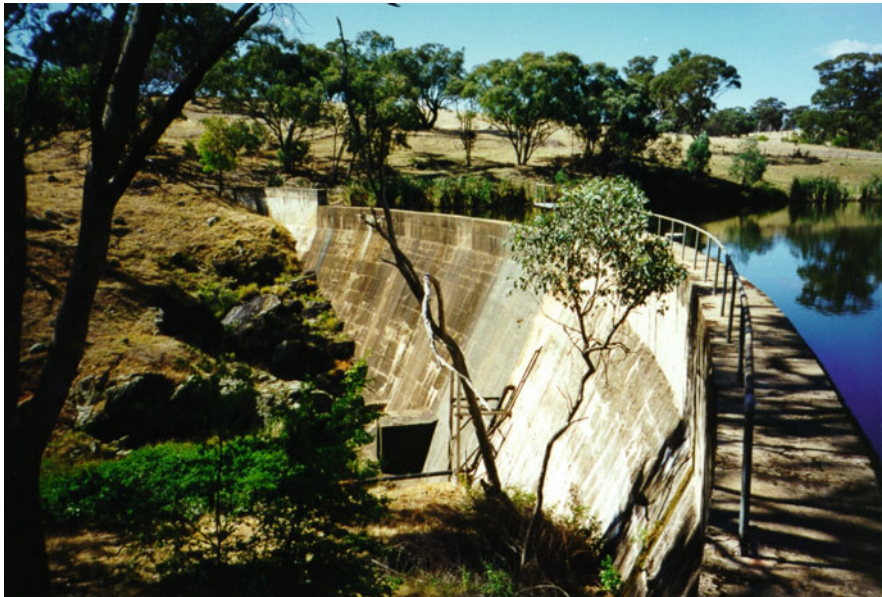
Reservoir Sedimentation in Australia under Extreme Conditions, Figure 4 Borenore Creek dam completed in 1928 – view from the left bank in December 1997. Note the old scour outlet system and the new water intake at half-height of the dam wall.

Completed in 1928, the Borenore Creek dam was built to supply water to the Orange-Broken Hill railway line. The dam is a concrete single-radius arch wall (17 m high, 123 m long at crest, 1.12-m crest thickness) (Figure 4). The catchment area is 22 km^2 , and the original storage capacity was $230,000 \text{ m}^3$. The dam was equipped with an outlet system and an overfall spillway. Interestingly, a new outlet (pipe inlet) was installed, later, about half-height of the dam, as a result of the reservoir siltation which amounted for $150,000 \text{ m}^3$ in 1981 (Figure 4). After being used by the NSW Railway Department, the dam has been used as the town water supply for Molong. The reservoir is used only as an emergency reserve today.

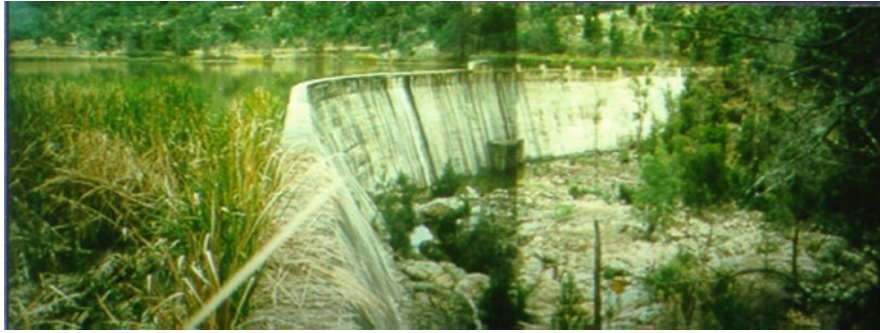
Reservoir Sedimentation in Australia under Extreme Conditions, Figure 5 Fully silted reservoir of Old Quipolly dam (Werris Creek NSW) completed in 1932 – view from the right bank in June 1997.

The old Quipolly dam or Quipolly dam No. 1 was completed in 1932 to supply town water for Werris Creek NSW, irrigation water and water for steam engines (Figure 5). The dam is a concrete single arch (19 m high, 184 m long crest), the catchment area is 70 km^2 , and the original storage capacity was $860,000 \text{ m}^3$. The reservoir suffered heavy sedimentation between 1941 and 1943 (Chanson and James, 1998). The reservoir was disused in 1955, and the reservoir is fully silted today. The reservoir acts now as a sediment trap for the new Quipolly dam (Quipolly dam No. 2) located downstream.

In Australia, the sedimentation of Quipolly reservoir between 1941 and 1943 was an extraordinary event. Overall, most sedimentation problems in Australia were experienced with small to medium size reservoir (catchment area less than 100 km² typically). In contrast, large Australian reservoirs have not been sedimenting rapidly at the exception of Melton and Eildon reservoirs. Heavy siltation at Eildon was experienced in 1940 during torrential rainfalls, following bushfires which destroyed more than 50% of the forest in the catchment (Joseph, 1953).

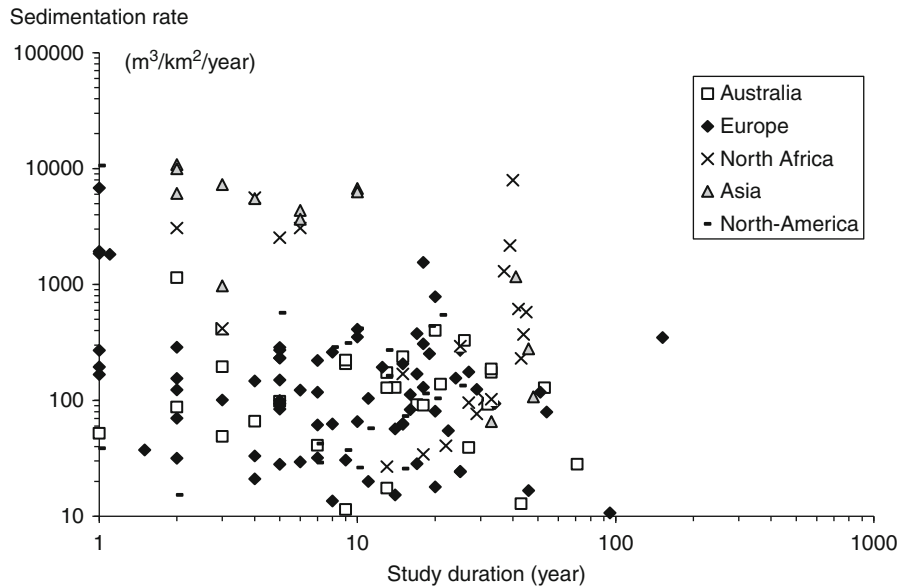
Reservoir Sedimentation in Australia under Extreme Conditions, Figure 6 Extreme siltation rates ($\text{m}^3/\text{km}^2/\text{year}$) as a function of study duration (year).

rates in Australia were high (Table 2). Table 2 compares the most extreme (well-documented) siltation events in North Africa, North America, Asia, Europe, and Australia. These data are summarized in Figure 6,

showing extreme siltation rates as a function of the duration of the study.

Figure 6 suggests that highest (recorded) siltation rates are observed during short duration studies (1–10 years).
