### Les crues de 2010-2011 dans le Queensland (Australie) : observations, premières réflexions et expérience personnelle

#### The 2010-2011 Floods in Queensland (Australia): Observations, First Comments and Personal Experience

Hubert CHANSON

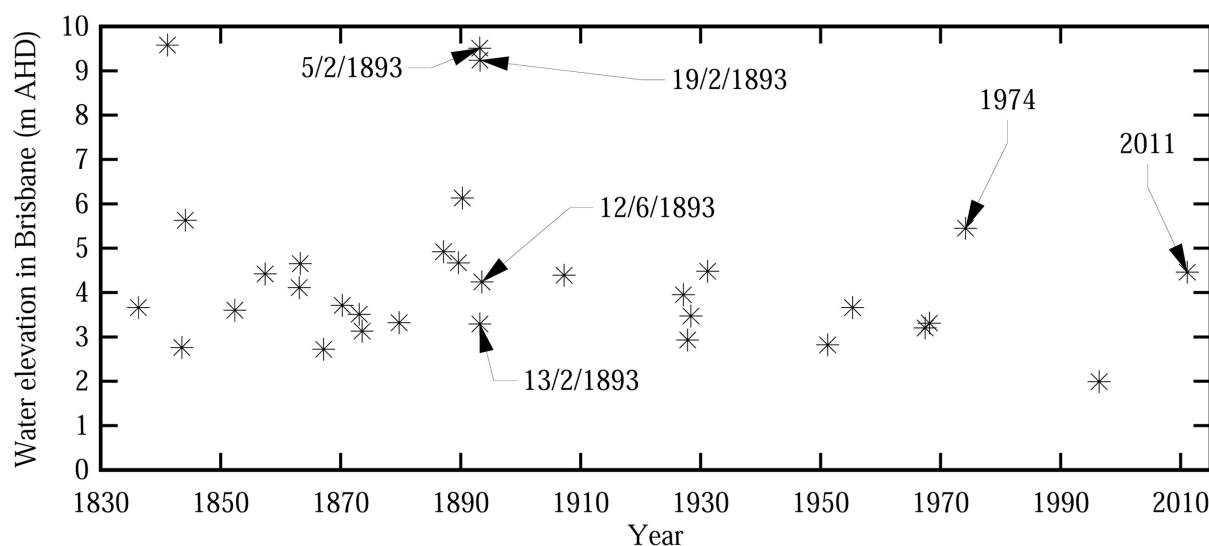
**Fig. 2 :** *Historical floods of the Brisbane River in the city of Brisbane and maximum water elevations for the period 1830-2011 (Ref. [2], [3], [4], [6], [10]).*

The floods in eastern Australia are sometimes linked with La Niña events during the El Niño Southern Oscillation (ENSO) cycle, as seen in 1916, 1917, 1950, 1954-1956, 1973-1975 and 2010-2011 [8]. In tropical and sub-tropical Queensland, major floods are a relatively common occurrence as illustrated in Figure 2. Figure 2 shows the major floods of the Brisbane River in the city of Brisbane for the last 180 years and the maximum water levels above the Australian Height Datum (AHD) that corresponds to the Mean Sea Level (MSL). While there have been a smaller number of major floods during the last 50 years, some extreme

was experiencing a long drought period. In 2007, for example, the combined water supply of the city of Brisbane fell below 17% (Fig. 4A) and the long-term forecasts were dire. On the opposite, Brisbane experienced a large number of major floods during the 19th century (Fig. 2). Following the 1974 flood, the Wivenhoe reservoir was completed with a long-term water supply capacity of  $1.15 \times 10^9 \text{ m}^3$  and an additional flood mitigation volume of  $1.45 \times 10^9 \text{ m}^3$  (Fig. 4). During the 2010-2011, the Wivenhoe reservoir contributed to a shorter flood period and lower flood levels in Brisbane although the reservoir reached about 190% of its nominal capacity on 12 January 2010.

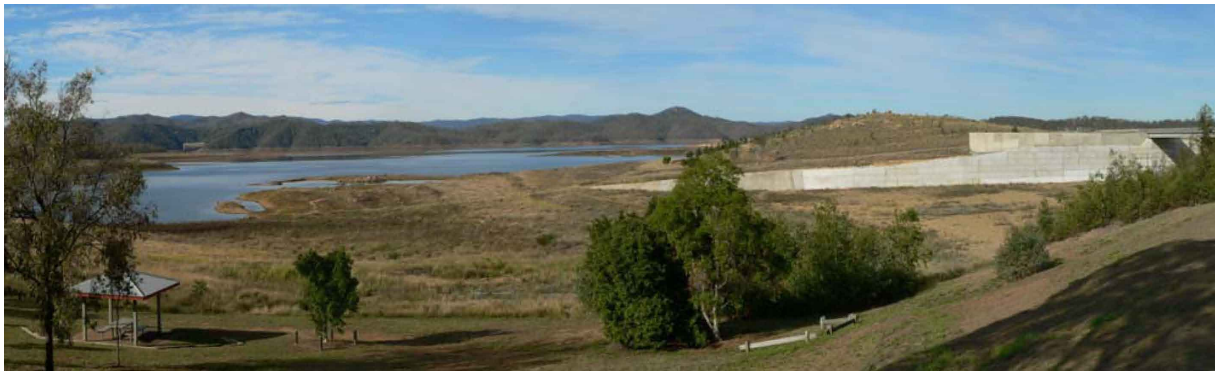
(A) Dry reservoir on 13 June 2007 viewed from the dam right abutment with the secondary spillway intake on the far right - The reservoir capacity was below 16%.

**Fig. 4 :** Wivenhoe Reservoir on the Brisbane River in South East Queensland - Completed in 1984, the reservoir has a dual purpose: flood mitigation and long-term water supply (it is the largest water supply for the city of Brisbane) - Note that the Bremer River and Lockyer Creek join the Brisbane River downstream of Wivenhoe dam.

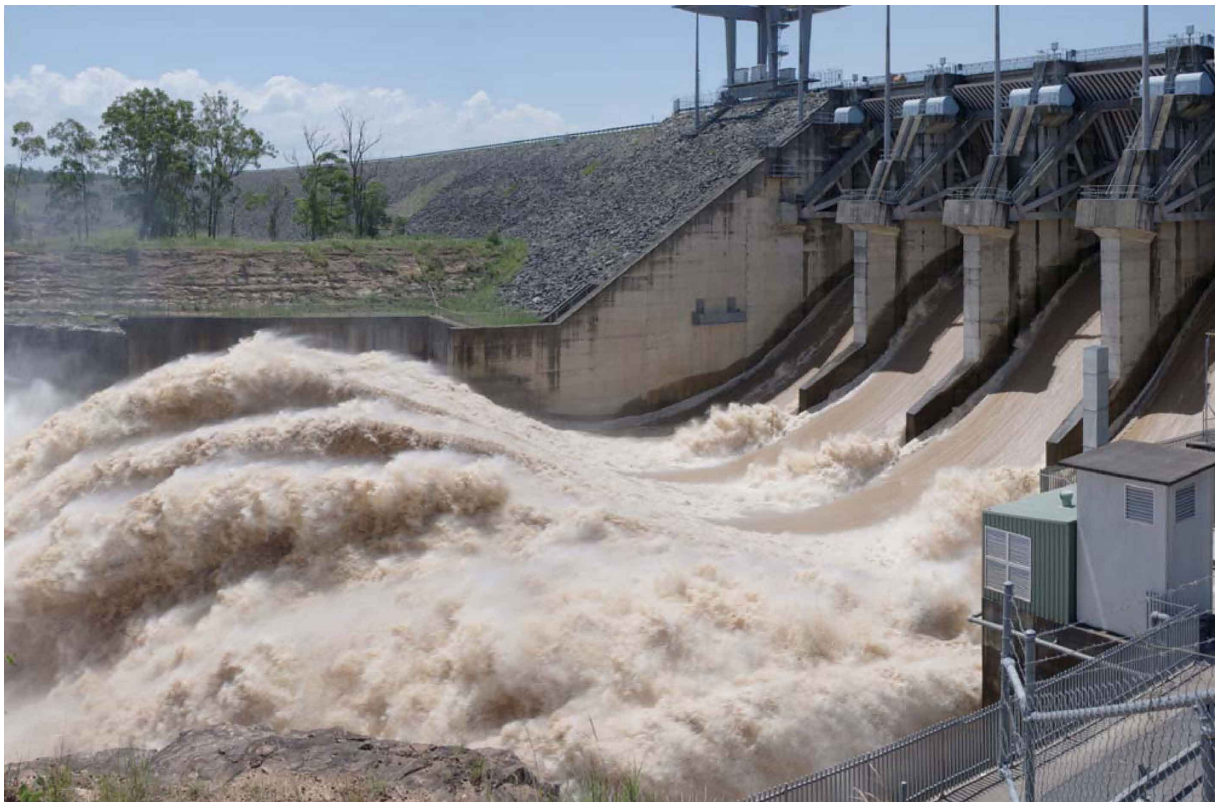
(B) Spillway operation on 17 January 2011 - The reservoir capacity was about 122%.

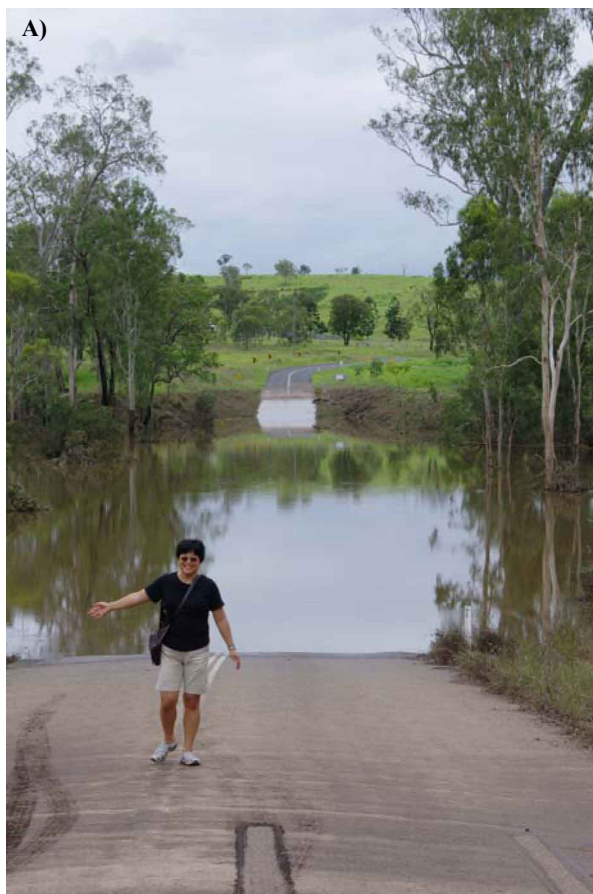
(A) Degibo Creek at Coringa, Burnett catchment (Central Queensland) on 30 December 2010 (see hydrograph in Figure 3A).

An implication of the widespread extent of the floods was the large number of road closures (e.g. Fig. 5A), isolat-

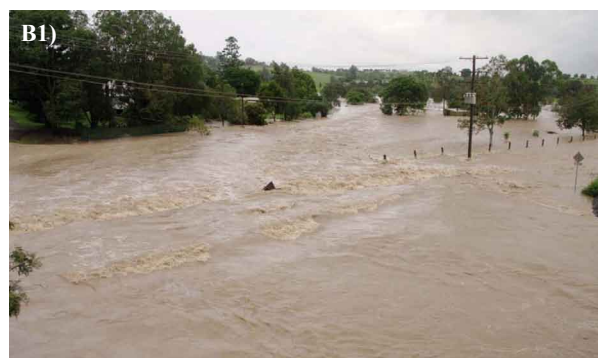
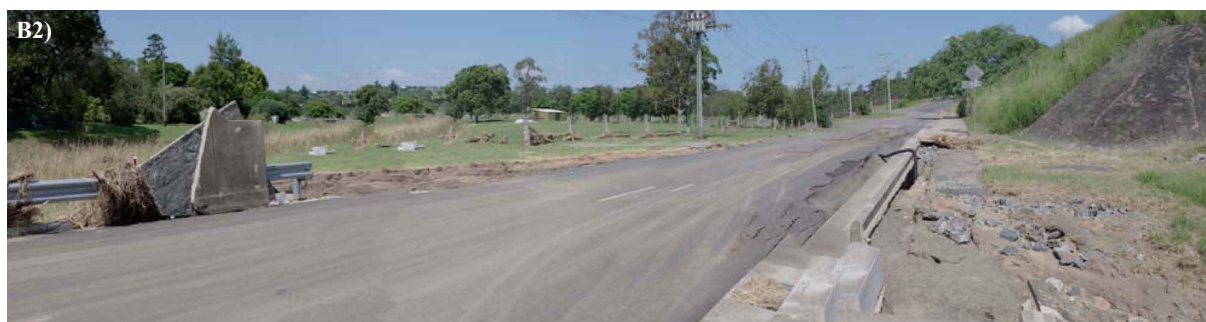
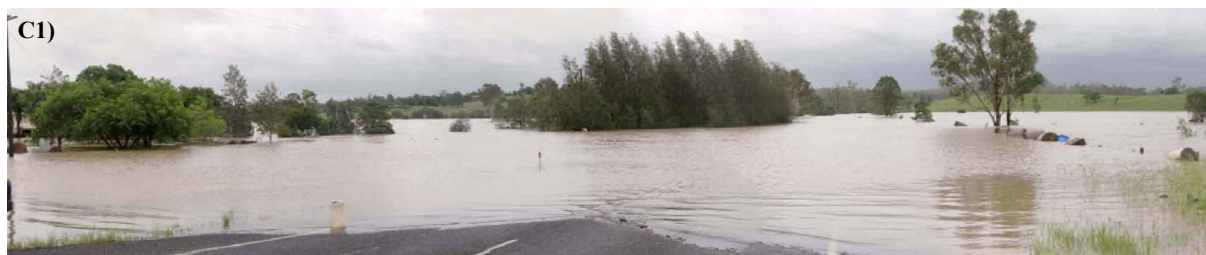
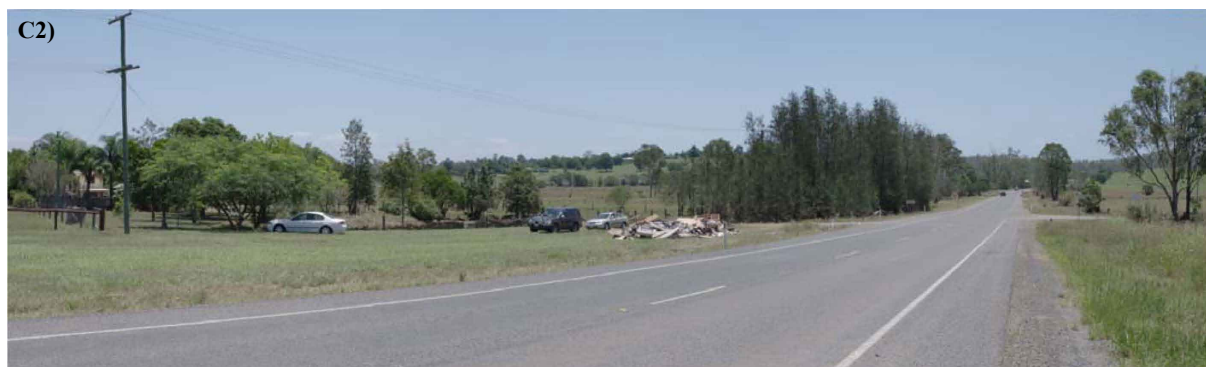
(B) Black Snake Creek Marburg about 60 km West of Brisbane, looking downstream - Note the footpath concrete slabs jammed into the road rails on both photographs.

(B1) On Tuesday 11 January 2011 at 16:31 - The tip of the concrete slabs is visible above the water surface in centre of the photograph.

(B2) On Monday 17 January 2011 at 14:26.

(C) Brisbane Valley Highway at Black Snake Creek (also called Fairnie Brook) 3 km SSW of Fernvale - View from the southern end of road.

(C1) On Tuesday 11 January 2011 at 15:52.

(C2) On Monday 17 January 2011 at 12:04.

Kenmore, Brookfield, Fernvale and Marburg. In the early afternoon, Moggill Road was closed at Rafting Ground. The road to Fernvale was closed when Black Snake Creek overtopped the road (Fig. 5C). The Warrego Highway was closed between Marburg and Minden. The flooded township of Marburg was devastated (Fig. 5B). (Note that Figures 5B and 5C show some photographs during and after the flood.) During the return trip to Brisbane, the author's car was one of the last vehicles to drive the eastbound Ipswich motorway past Goodna, as the motorway was closed shortly after and later submerged.

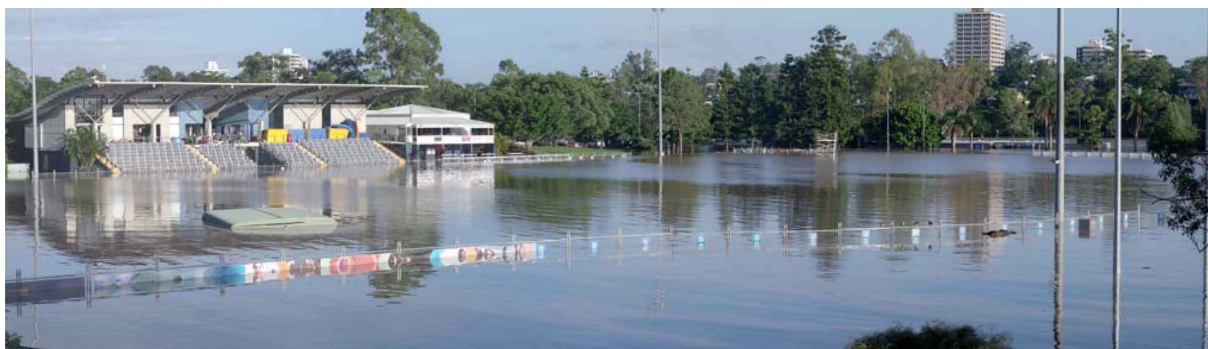
(D) Submerged campus of the University of Queensland in Brisbane on Wednesday 13 January 2011 morning at 06:25 - The main channel of the Brisbane River is in the right background behind the trees (see hydrograph in Figure 3E).

On 12-13 January 2011, he inspected the Brisbane River flooding in Brisbane (Fig. 5D & 5E). A key feature was the rise of the water levels in Brisbane on Wednesday 12 January 2011. The rapid rise of the Brisbane River on 12 January

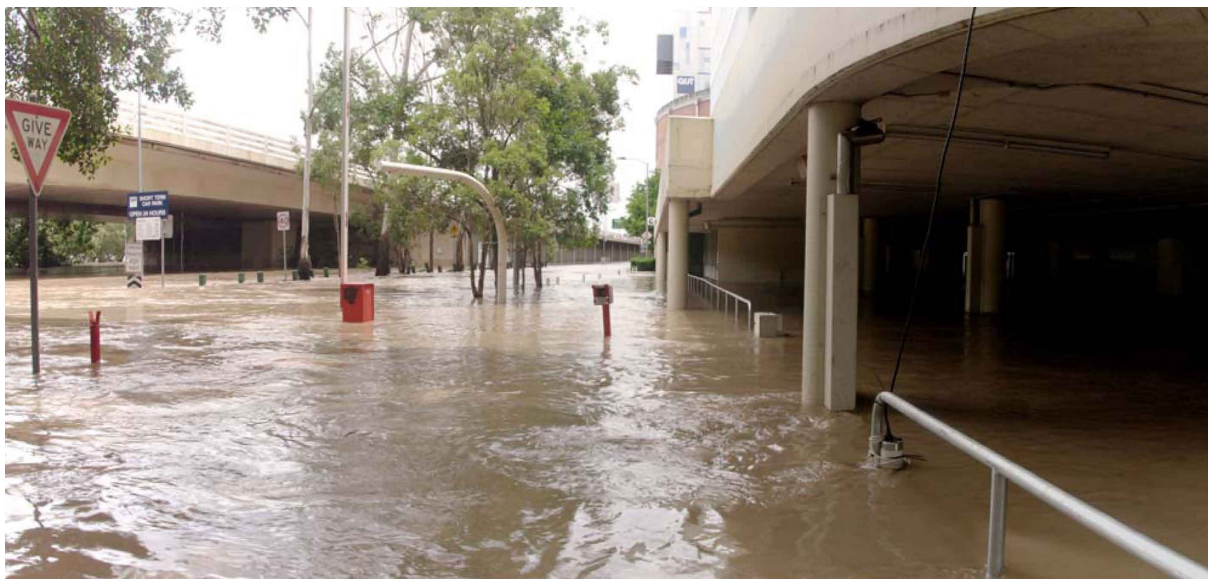
(E) Submerged campus of Q.U.T. in the city centre on Wednesday 13 January 2011 morning at 11:40 - Looking upstream at the flood flow between the South-East Freeway (left) and C Block (right) with the main channel of the Brisbane River on the far left (see hydrograph in Figure 3E).
