RAPID RESERVOIR SEDIMENTATION OF FOUR HISTORIC THIN ARCH DAMS IN AUSTRALIA

By H. Chanson¹ and P. James²

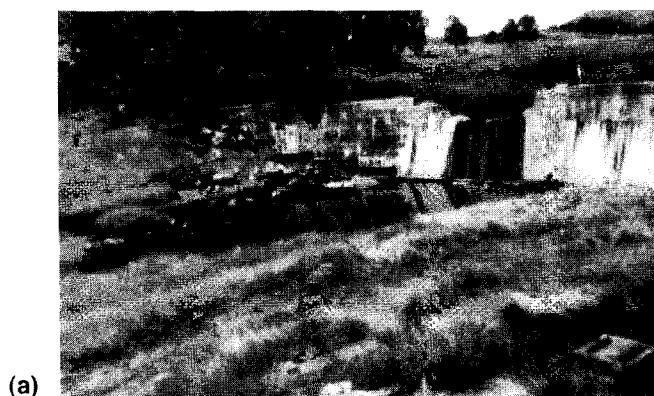
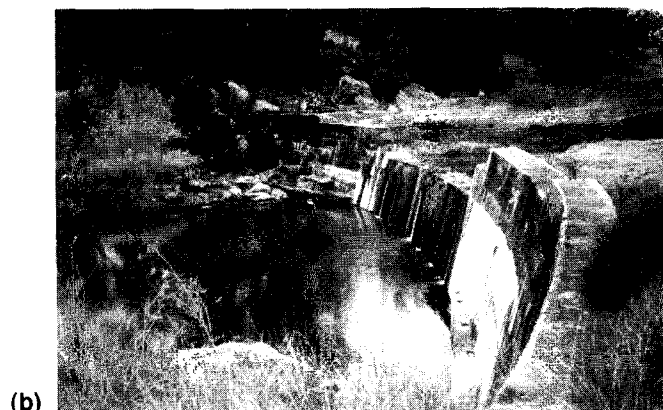
FIG. 3. Gap Weir (1902): (a) View from Downstream (1960s Photograph); (b) View from Left Bank, with Creek Flowing from Right to Left (1997 Photograph)

The dam wall is a single-arch concrete structure with upstream vertical face and inclined (battered) downstream face ($\sim 73^\circ$ angle with horizontal). The original spillway was an overfall spillway extending over most of the weir crest followed by a relatively deep plunge pool, but no scour outlet was built (although a drawing prior to construction showed one).

The reservoir became fully silted by 1924. It was abandoned and replaced by available water supply from Quipolly Creek and later from the Quipolly dam. (The change to engine motors occurred in the 1970s and did not affect the decision.) After 1924, the dam wall was blasted twice to facilitate the passage of flood flow and to limit upstream flooding. Interestingly,

the reservoir is located downstream of a long flat floodplain (slope < 0.2 , streamwise length > 6 km). The river, cutting through into the reservoir sediment, highlights the silty material caught by the weir, suggesting a siltation process by suspended load.

The Gap weir was built without a bottom outlet; thus it could not be scoured. Note, further, that the spillway capacity (35–40 m³/s) was small compared with the Moore Creek and Korrumbyn Creek dams, both of which have a smaller catchment.

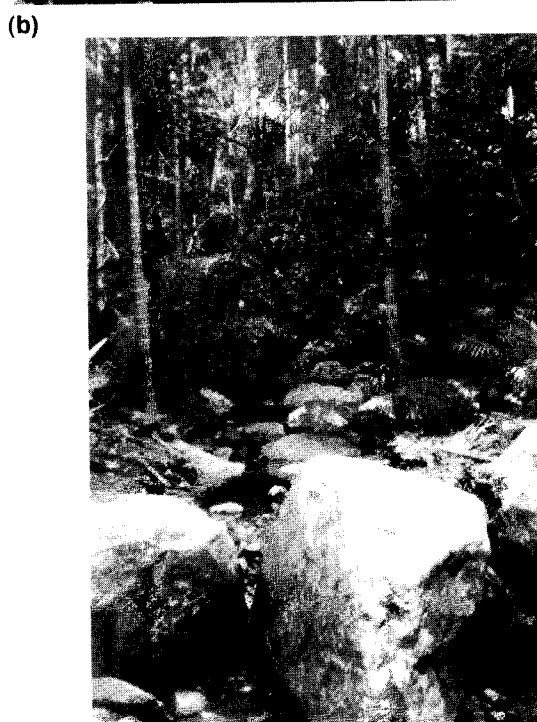
FIG. 4. Korrumbyn Creek Dam (1918): (a) Plan View, from Original Drawing after Construction; (b) View from Downstream Showing Bottom Outlet System on Left and Pipe to Murwillumbah (1997 Photograph); (c) View Looking Upstream of Korrumbyn Creek 1.5 km Upstream of Dam Wall Showing Coarse Sediment Material (1997 Photograph)

after construction and noted several significant changes in design, including the dam height.] It was equipped with two bottom outlets (a pipe outlet and a scour valve) and an overfall spillway. The catchment area is only about 3 km², for an original volume of 27,280 m³.

The dam was rapidly abandoned because a log jammed the scour pipe entrance during a flood. It could not be removed and the reservoir silted up very quickly by bed load. Further, during dry periods, the water level would drop and the water would turn green and become foul as it warmed up, making it unfit for use. The dam still stands today, the reservoir being occupied by an overgrown tropical forest (Fig. 4).

The Korrumbyn Creek dam had an insufficient catchment area (3 km²). Although the mean annual flow rate could “theoretically” fulfill the water needs of Murwillumbah, it was known that the stream discharge was very irregular. In 1916, the average weekly flow rate ranged from 0.75 L/s (Jan. 2–8, 1916) to 886 L/s (April 8–15, 1916), and the spillway was sized for a 125,000 L/s flood. All told, the reservoir never properly supplied Murwillumbah with water. Furthermore, the catchment is very steep: the stream bed slope is larger than 7.6° (0.133V/1H) in the first 2 km upstream of the dam! This caused significant sediment load in the creek. Today the riverbed still exhibits a wide range of sediment materials [Fig. 4(c)], and bed-load siltation could be predicted with contemporary experience (in the opinion of the authors, after inspection of the riverbed).
