The Enshu Coast of Japan

Hubert Chanson

Shin-ichi Aoki

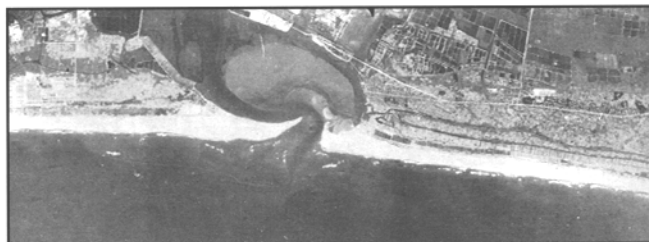
Figure 2. Aerial photograph of Imagire Inlet at Hamana Lake in 1946 showing natural sand bars formed at the entrance. Jetties were constructed between 1961 and 1973. These have interrupted longshore sediment being transported from east to west, from the Tenryu River to Irigo Cape (right to left). Photo courtesy of Japan Geographic Survey Institute.

The Enshu coast has been adversely affected by high, typhoon-generated waves and storm surges, and severe tsunamis. For example, the mouth of Hamanako Lake was drastically altered in AD 1498 by a tsunami generated by an 8.6 magnitude earthquake. The estuary mouth shifted by about 3.5 km turning the previously freshwater lake into a saltwater system. Figures 2, 3, and 4 show how structures altered the coastline configuration

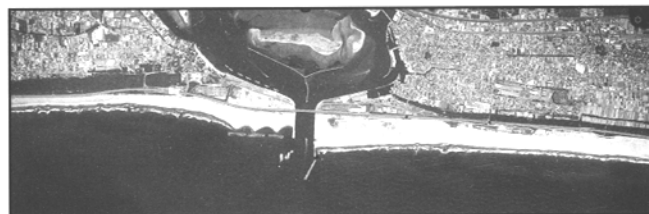
Figure 3. Imagire Inlet taken in 1997. Three detached breakwaters were constructed to protect the western beach against erosion. Photo courtesy of Japan Geographic Survey

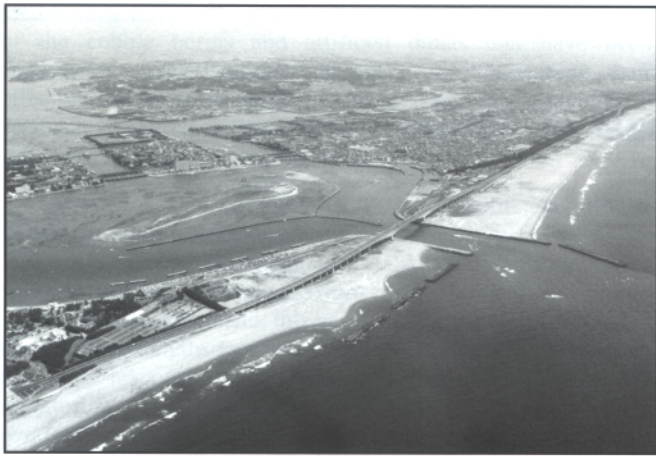
Figure 4. Imagire Inlet in 1999, showing present-day conditions. Photo courtesy of Mr. Kato, Omotehama Network.

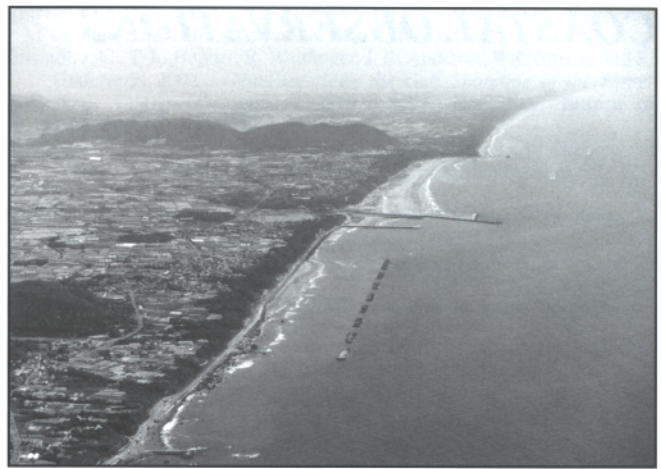
Figure 5. Aerial photograph of Akabane Harbor. Like Imagire Inlet, the breakwaters have caused drastic shoreline change on both sides of the harbour. Photo courtesy of Mr. KATO, Omotehama network.

During typhoons, the small Akabane Harbor is often affected by harbor resonance and storm surge. A large storm surge barrier was built behind the basin to prevent salt intrusion into the adjacent fields. Figure 5 shows the effect of the jetties and coastal protection near Akabane Harbor. Figures 6-9 show recent pictures at Terasawa Beach, between Imagire Inlet and Akabane Harbor. Additional photos may be found at http://www.uq.edu.au/~e2hchans/photo.html#Coast_Japan.

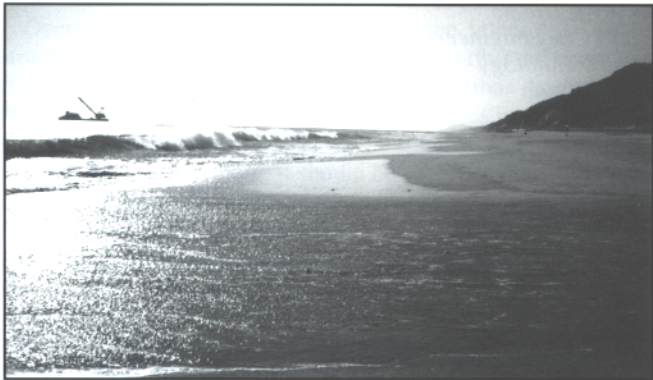
Figure 6. Wave runup and breakers on 30 Jan 1999 at Terasawa Beach between Imagire Inlet and Akabane Harbor. Note crane installing submerged concrete breakwater (left background).

Figure 8. Breakers and off-shore breaking with SE winds and good surf waves - Terasawa Beach photograph taken from the cliff on 14 Mar 1999. A submerged breakwater was installed off the beach the previous winter (Figure 6).

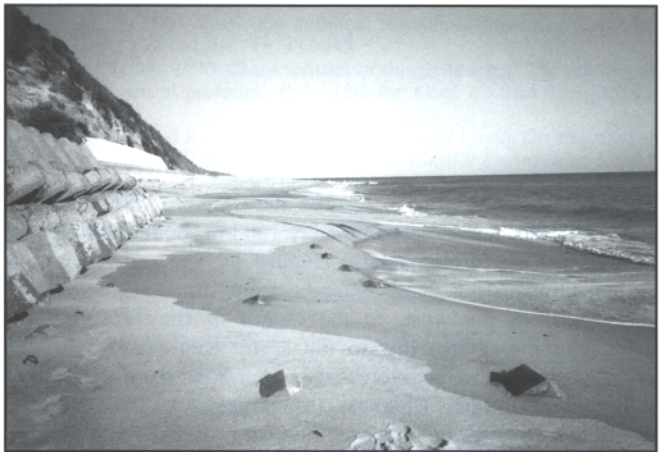
Figure 7. Terasawa Beach wave runup near high tide and coastal protection on 30 Jan 1999.

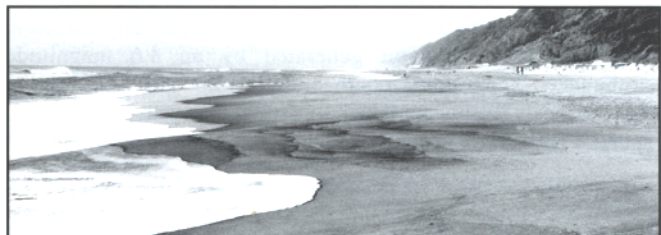
Figure 9. Sunrise at Terasawa Beach, 25 Oct 2001. Note sediment sorting indicated by dark stripes.
