The impact of Typhoon Morakot on the southern Taiwan coast

Hubert Chanson

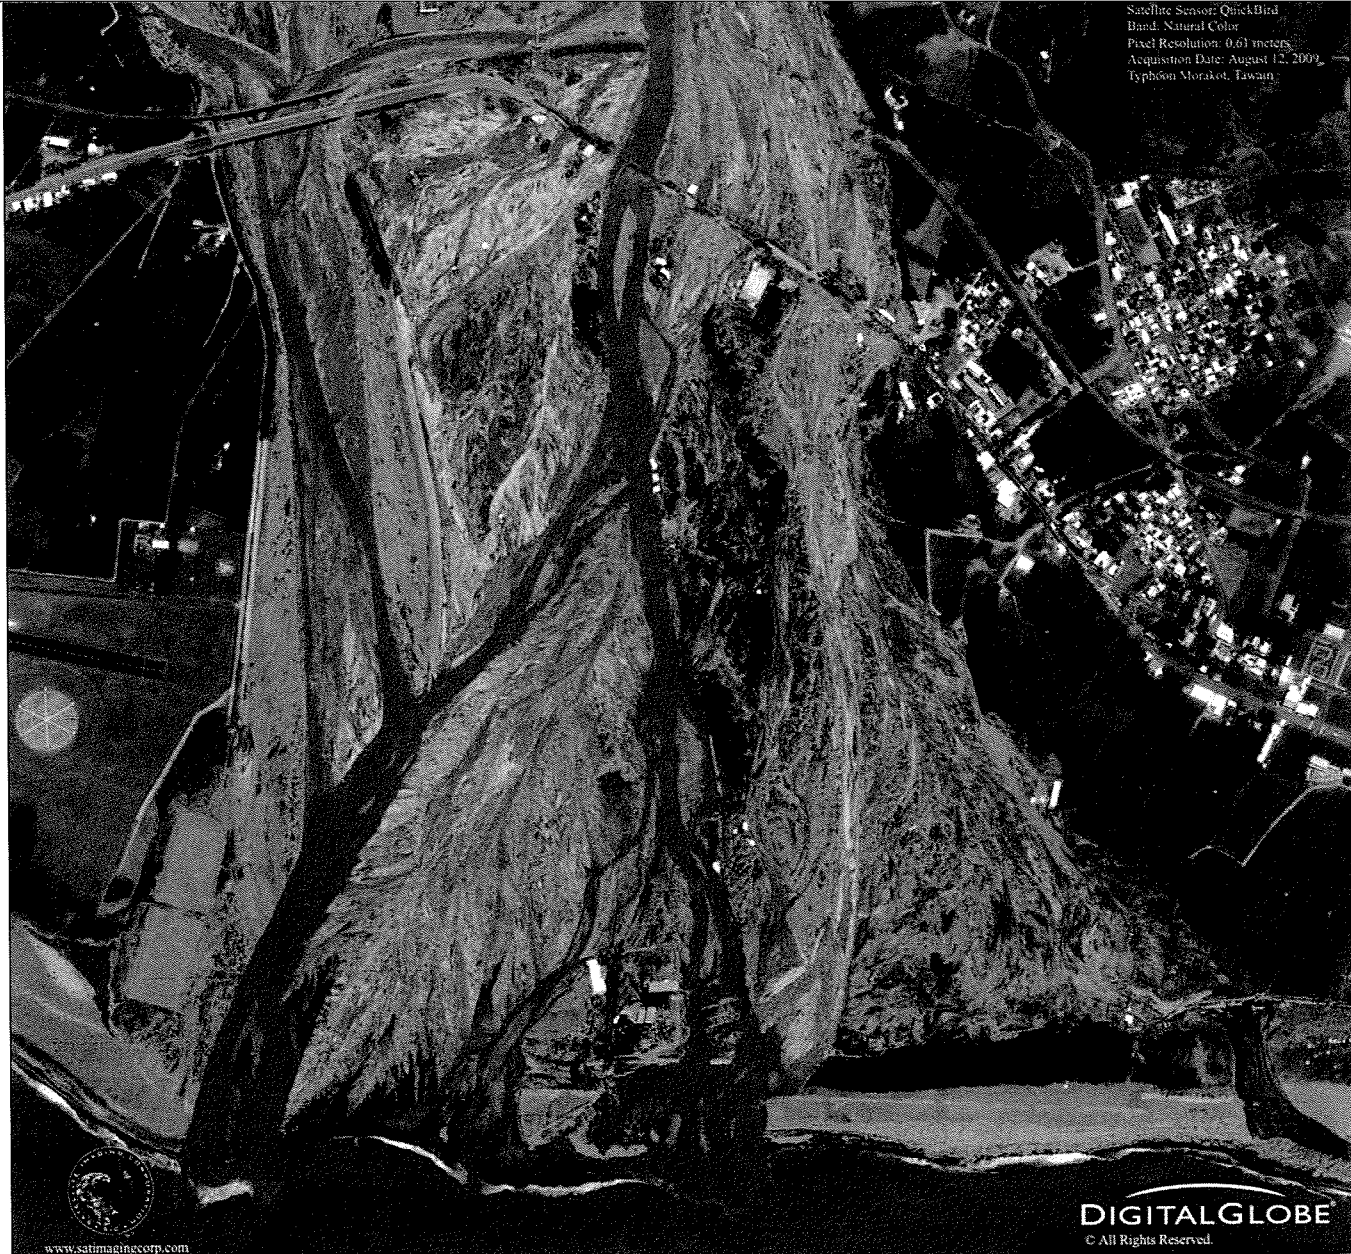
Figure 2. Photograph of the Taimali River mouth on 12 August 2009 (courtesy of Satellite Imaging Corporation). Note the devastated Taimali township on the right and the damaged railway bridge (top), and road <42> bridge (just beneath), as well as the airfield on the bottom left. From left to right, the distance is about 2.3 km.

and widened considerably its river bed, covering townships and farmland. Figure 2 presents an aerial view of the river mouth shortly after the typhoon. It shows the damaged bridges (top) and the nearly 2 km wide river mouth.

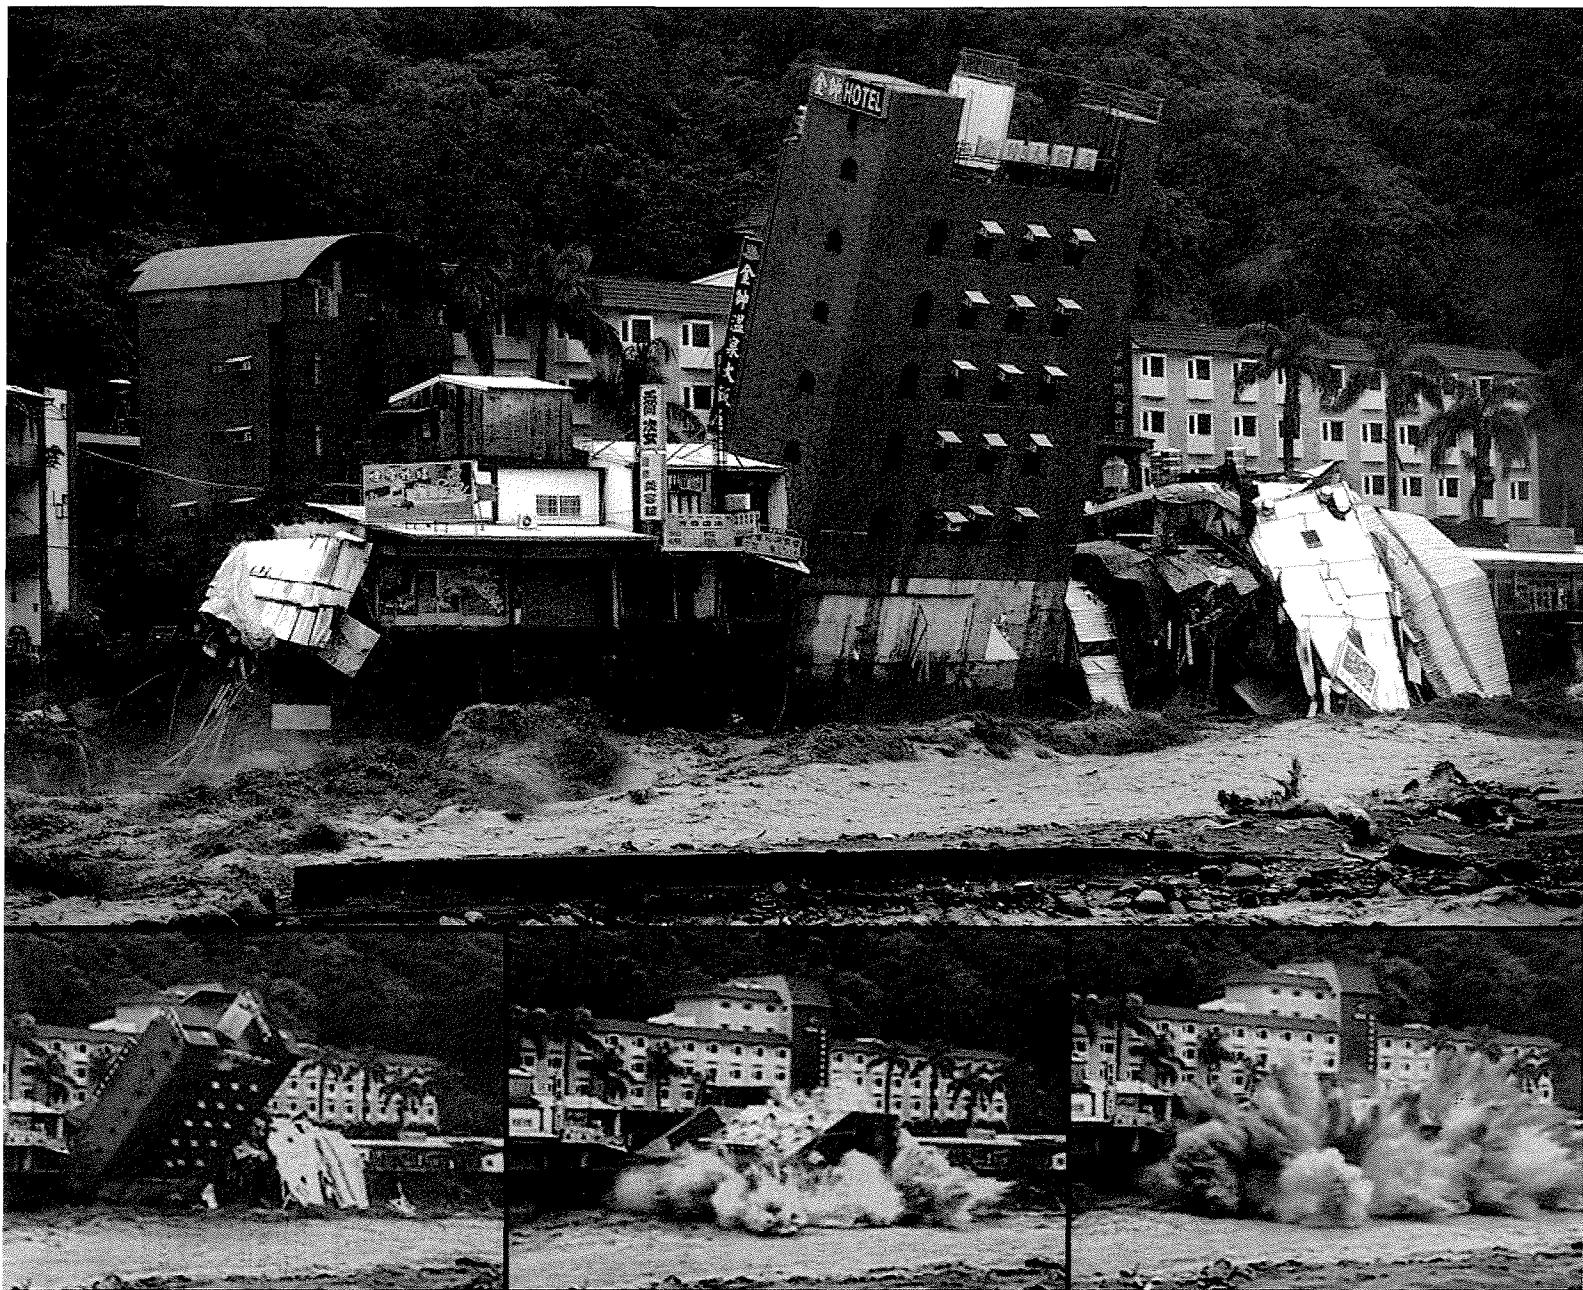
Figure 3. Photographs of the collapse of Jinshuai Hotel in the Jihben River (Taitung county) (courtesy of <http://www.boston.com/bigpicture>). Top: Shortly before the collapse; bottom: building collapse on Sunday, 9 August 2009.

Another affected area was the Jhihben (or Zhiben) township on the Jhihben River, just 5 km upstream of the river mouth, south of Taitung city. The area is a touristic region well known for its hot-springs. The collapse of the Jinshuai (or King Shai) Hotel into the Jhihben River was shown on television worldwide (Fig. 3). The hotel was located in the outer bend of the river behind the river bank levee, the main road, several stores and a parking (Fig. 4A). All were washed away when the river scoured its outer

bank and, later, the building foundations. The hotel building fell like a monolith on 9 August 2009 (Fig. 3, bottom). Figure 4 shows some photographs of the river taken in 2006 and showing the hotel building. The author drove in front of the Jinshuai Hotel in December 2008 and little had changed since 2006.

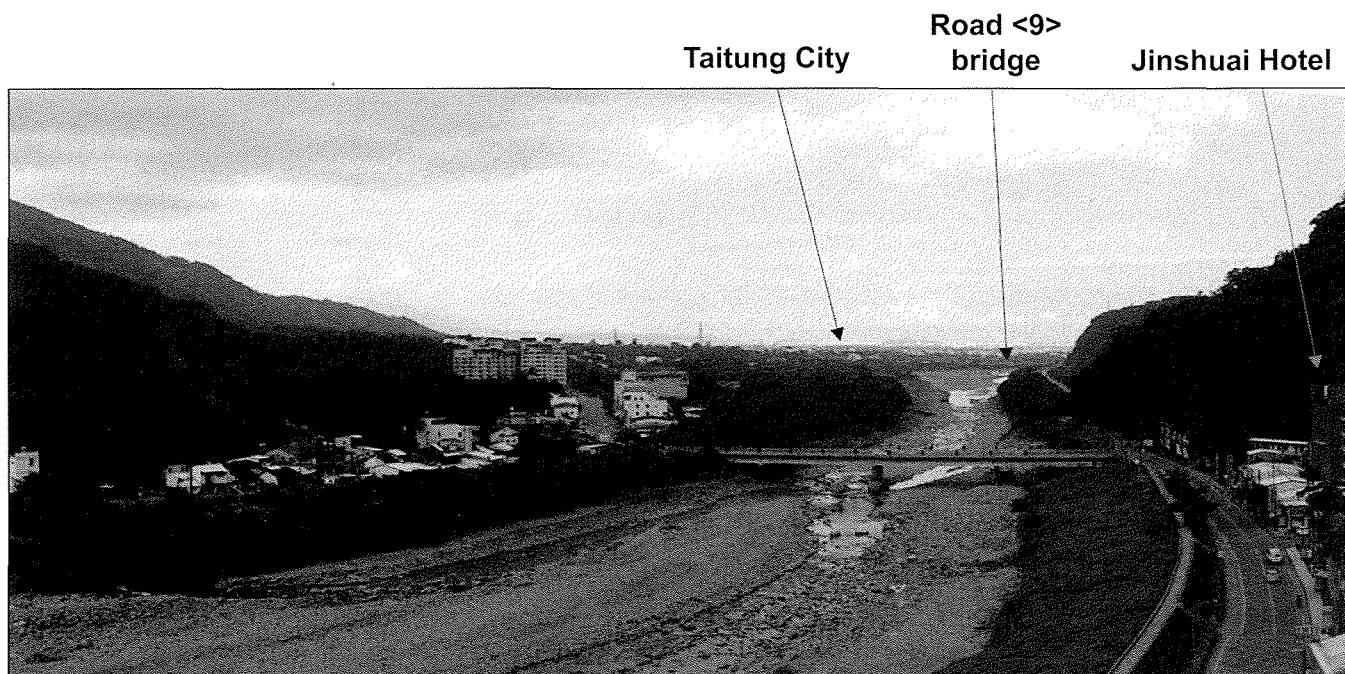
Figure 4. Photographs of the Jhihben River (Taitung county) prior to the Morakot Typhoon. (A, above) Jhihben River at Jhihben township looking downstream on 21 November 2006. The Jinshuai Hotel is the dark red building on the far right. (B, below) Jhihben River, looking upstream with Jhihben township in the background on 22 November 2006. The photograph was taken on the Road <9> bridge located 2 km downstream of Jhihben township.

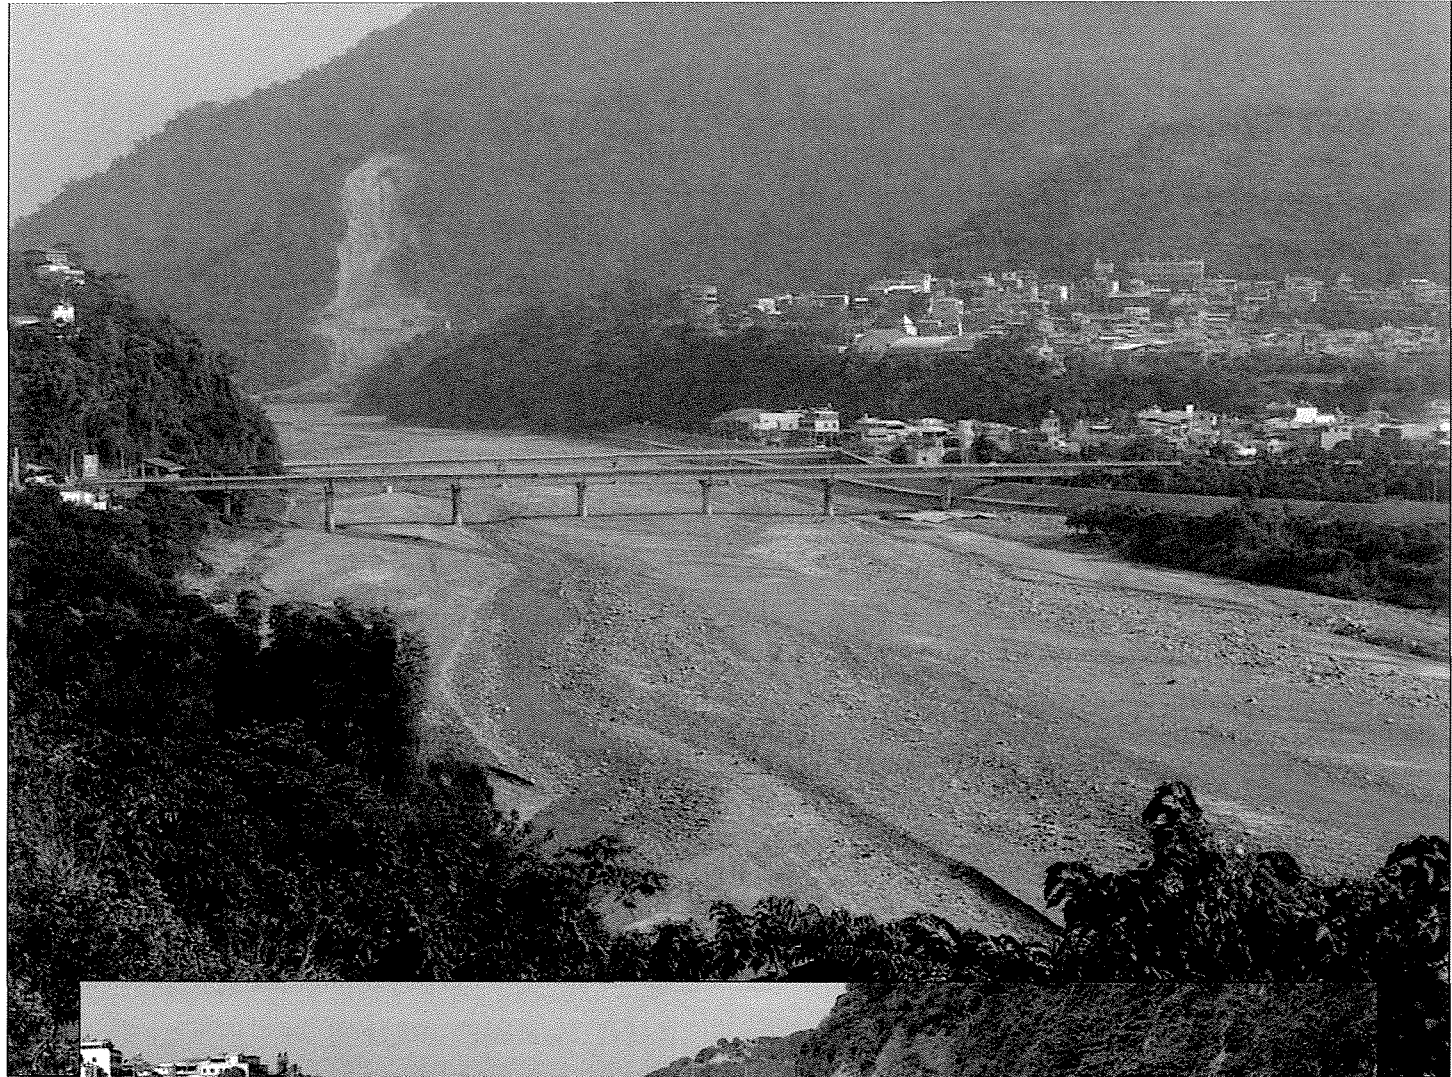
Figure 5 (opposite page, top). Photographs of the Ai-lia-ci River at Shueimen township (Sandimen, Pingtung county). (A, top) Looking upstream on 16 December 2008 with Shueimen township (on the right) and the two road bridges (in the middle). Note the huge amount of bed load material in the river bed and the recent landslide in the mountain in the background. (B, middle) Looking downstream on 22 December 2008 at Shueimen, with the township on the left and the bridges in the background. The children in the foreground give the scale of the sediment load and debris left after the last flood.

ures 5 and 6 present some photographs highlighting the large amount of sediment materials transported during the previous floods. Figures 5A and 6 illustrate also the steep slopes of the catchments.

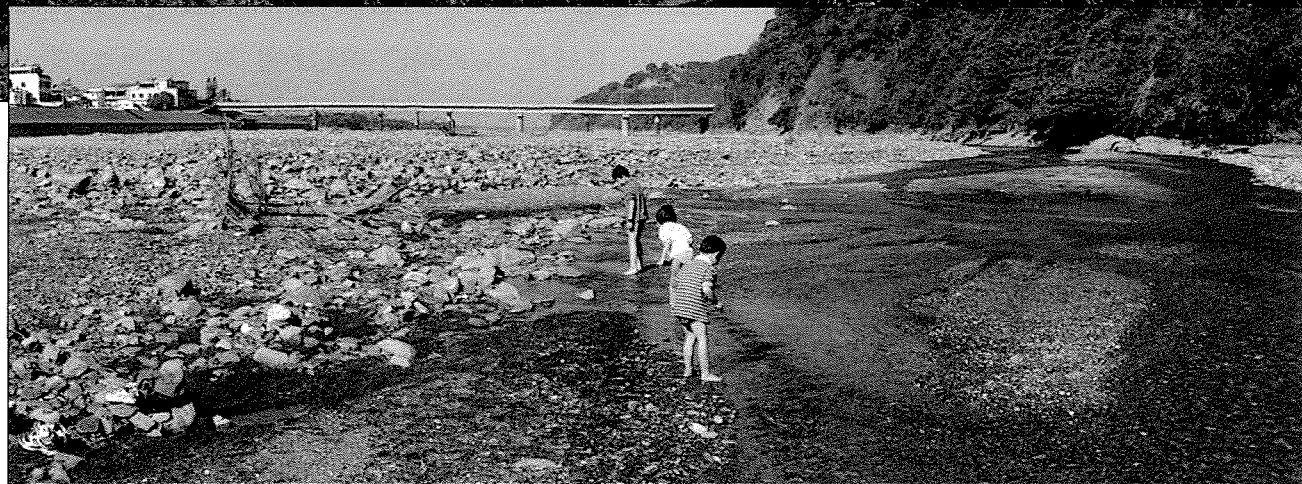
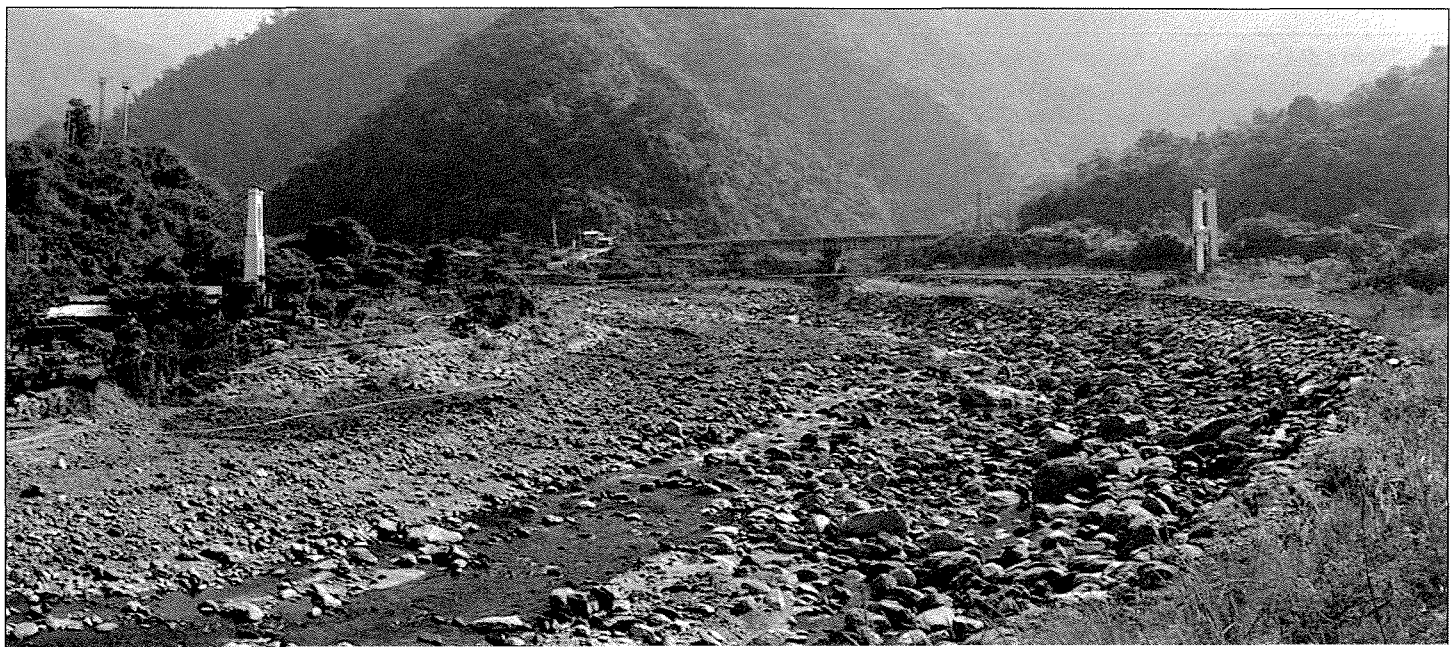
Figure 6 (opposite page, bottom). Photograph of the Lai-sheu River at Lai-yi and Danlin (Pingtung county) on 16 December 2008, close to the intersection of roads <185>, <112> & <110> - Looking upstream, note the sediment materials on the river bed; some river bed rocks were more than 2-3 m high.
