# **SILTATION OF AUSTRALIAN RESERVOIRS : SOME OBSERVATIONS AND DAM SAFETY IMPLICATIONS**

H. CHANSON and D.P. JAMES

Department of Civil Engineering, The University of Queensland, Brisbane QLD 4072,  
Australia

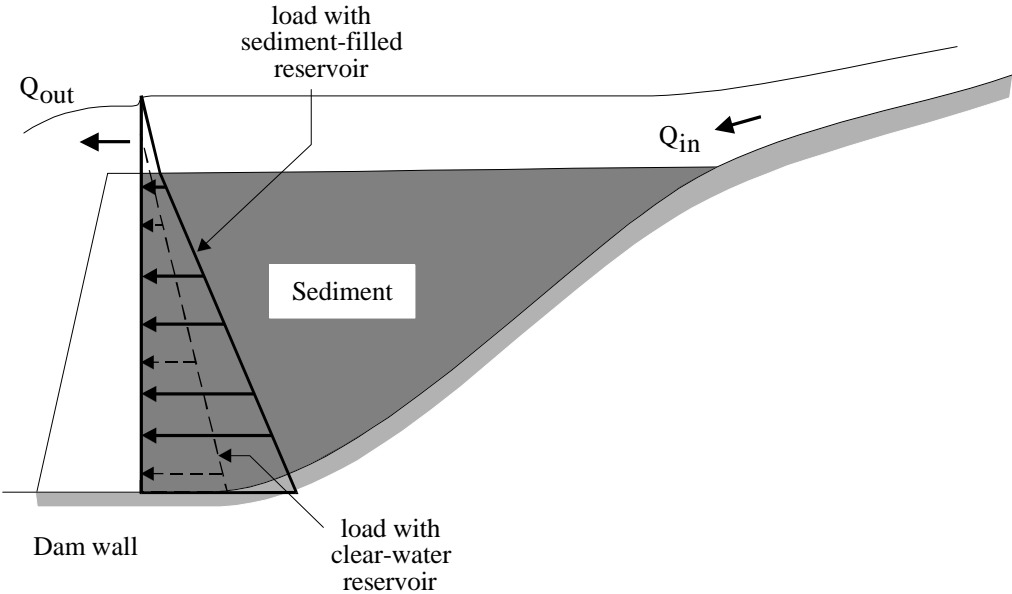
Reservoir siltation affects the safety of old reservoirs in several ways. The reservoir sediment increases the load on the dam wall. The reduction of reservoir storage capacity reduces the attenuation of the flood and it may increase the outflow, hence the head above crest, for a given reservoir inflow. Often the original hydrological study of ancient reservoirs relied on a small sample of data, and the estimated inflow underestimated the 'real' probable maximum flood (PMF) of the catchment-reservoir system. Altogether the sediment weight and larger head above crest create higher pressures on the dam wall (fig. 1).

Figure 1 - Effects of reservoir siltation on dam wall pressure
