A review of accidents and failures of stepped spillways and weirs

H. Chanson, ME, ENSHM Grenoble, INSTN, PhD(Cant), DEng(Qld), EurIng, MIEAust, MAHR

Proc. Instn Civ. Engrs Water & Mar. Engng, 2000, 142, Dec., 177-188

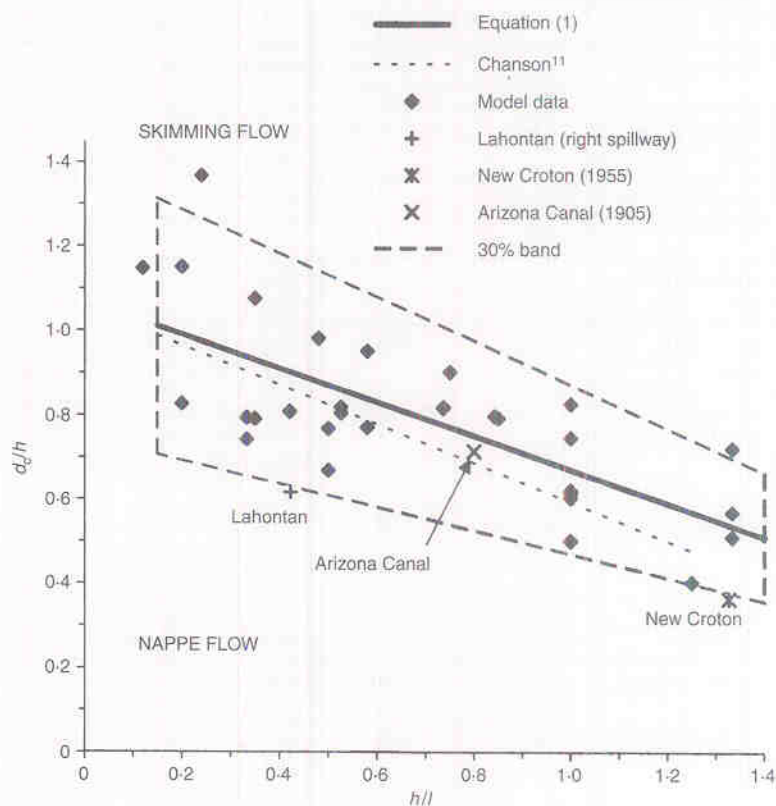
height and l is the step length (Fig. 2). Equation (1) is limited to flat, horizontal steps for h/l ranging from 0.15 to 1.4 and it characterizes the onset of skimming flow for uniform or quasi-uniform equilibrium flows down prismatic, rectangular channels. Its accuracy is within $\pm 30\%$ (Fig. 2). For accelerating or decelerating flows (i.e. rapidly varying flows), equation (1) is inaccurate and a more complete analysis is required (e.g. Chanson²³).

Fig. 2. Onset of skimming flow: comparison between equation (1), Chanson's correlation¹¹ and model data¹²⁻²²

47. The transition between nappe and skimming flow must be avoided. It is characterized by hydrodynamic instabilities causing additional fluctuating loads on the structures, and the resulting fatigue might increase the rate of failure. Fig. 2 illustrates that the transition regime is related to the flow rate (or critical depth), step height and chute slope. If further provides some indication of the range of flow conditions for which transitory flows might occur.
