## DISCUSSION / DISCUSSION

## Discussion of "Stability of concrete macro-roughness linings for overflow protection of earth embankment dams"<sup>1</sup>

H. Chanson

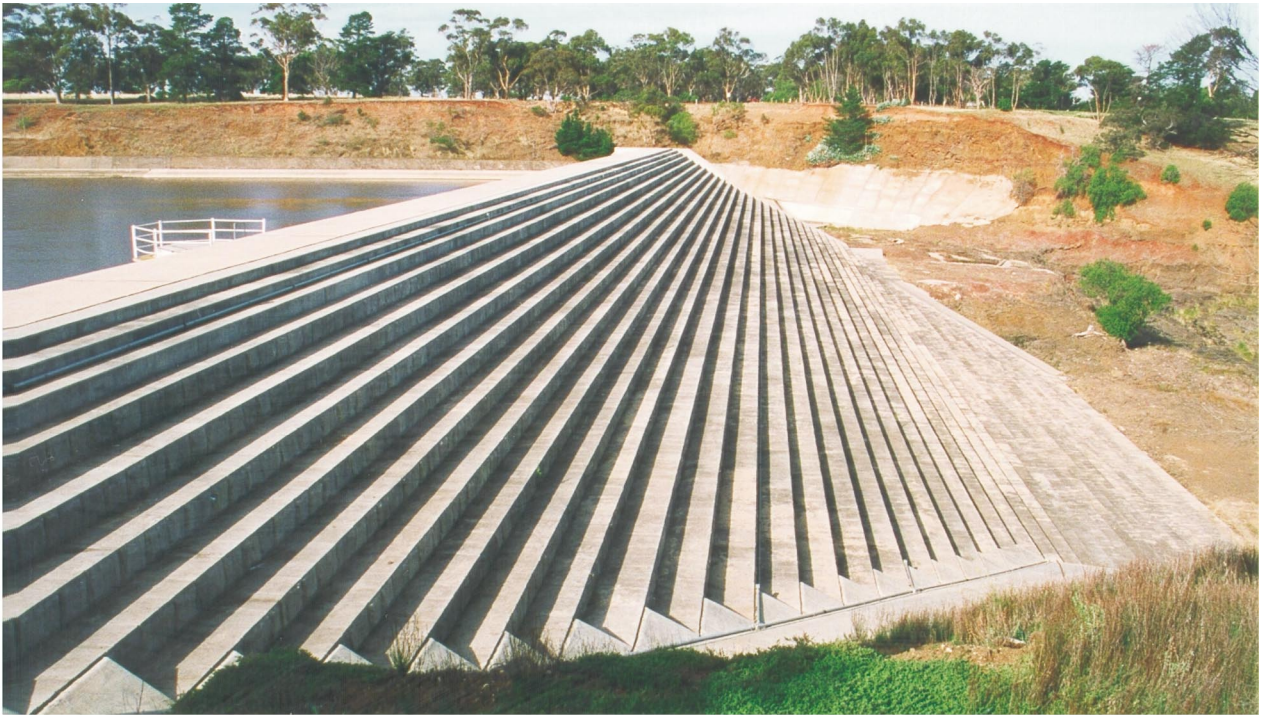
**Fig. 1.** Embankment dam stepped spillways: (a) Melton dam secondary spillway on 30 January 2000. Completed in 1916, the Melton dam was equipped in 1994 with a secondary spillway ( $Q_{des} = 2800 \text{ m}^3/\text{s}$ , step height  $h = 0.6 \text{ m}$ ). (b) Choctaw 8A dam auxiliary spillway (courtesy of Craig Savela and the U.S. Department of Agriculture Natural Resources Conservation Service) ( $Q_{des} = 481 \text{ m}^3/\text{s}$ ,  $h = 0.61 \text{ m}$ , crest width  $B_{crest} = 51.8 \text{ m}$ ).

During the last two decades, a number of embankment dam spillways were designed with concrete overtopping protection shaped in a stepped fashion (Chanson 2001, pp. 220–230). During the 1990s, the construction of secondary stepped spillways accounted for nearly two thirds of dam construction in the United States (Ditchey and Campbell 2000). The preferred construction method was roller-compacted concrete overlays placed on the downstream slope. Figure 1 presents two examples. Figure 1a shows the Melton dam secondary spillway completed in 1994. With a discharge capacity  $Q_{des} = 2800 \text{ m}^3/\text{s}$ , it is the world's largest embankment stepped spillway (Chanson 2001, pp. 221–223). Figure 1b shows a newer embankment dam designed and built with a secondary stepped spillway system ( $Q_{des} = 481 \text{ m}^3/\text{s}$ ). Although most research on stepped spillway hydraulics focused on steep chutes for gravity dams (average invert slope  $\alpha \approx 50^\circ$ ), recent studies have added new insights to the complicated overflow hydrodynamics (Chanson and Toombes 2001, 2002; Gonzalez 2003).

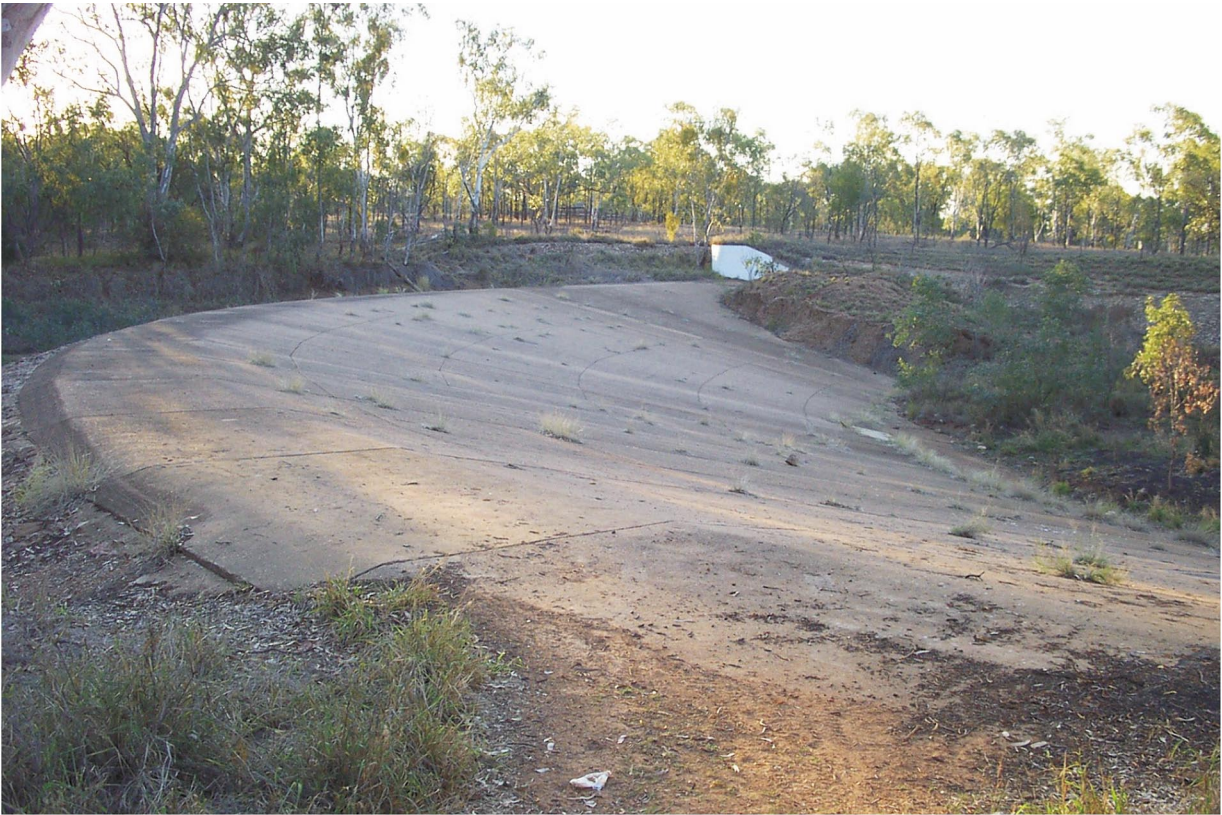
**Fig. 2.** Minimum energy loss weirs: (a) Sandy Creek weir at Clermont, Queensland, Australia, built in 1963. Dam height = 6.1 m,  $Q_{des} = 850 \text{ m}^3/\text{s}$ ,  $B_{crest} = 116 \text{ m}$ . View from the right bank on 3 September 2002 (courtesy of Keith James). (b) Chinchilla weir, Queensland, Australia, built in 1973. Dam height = 14 m,  $Q_{des} = 850 \text{ m}^3/\text{s}$ ,  $B_{crest} = 410 \text{ m}$ . View from the right bank on 8 November 1997.

A very different concept of overflow embankment spillway is the minimum energy loss (MEL) weir design. The concept of a MEL weir was developed by the late Gordon R. McKay (1913–1989) to allow the passage of large floods with minimum energy loss, hence with minimum upstream flooding. The first MEL weir design was the Sandy Creek weir at Clermont Queensland, Australia (built in 1962; Fig. 2a). The largest MEL weir is the Chinchilla weir in

Queensland, Australia (built in 1973), which is listed as a "large dam" by the International Commission on Large Dams (Fig. 2b). A MEL weir is typically curved in plan with converging chute sidewalls, and the overflow spillway chute is relatively flat (Fig. 2). The downstream energy dissipator is concentrated near the channel centreline away from the banks. The in-flow Froude number remains low and the rate of energy dissipation is small compared with that of a traditional weir. For example, both Clermont and Chinchilla weirs were designed to give no afflux at design flow  $Q_{des}$ . In 1974, the Chinchilla weir passed a discharge of  $1130 \text{ m}^3/\text{s}$  with a measured afflux of less than 100 mm (Turnbull and McKay 1974). Ideally, a MEL weir could be designed to achieve critical flow conditions at any position along the chute and, hence, to prevent the occurrence of a downstream hydraulic jump (Chanson 1999, pp. 418–419). This is not always achievable because the variations of the tailwater flow conditions with discharge are often important. Minimum energy loss weirs are typically earthfill structures, and the spillway section is protected by concrete slabs. Construction costs are minimal. A major inconvenience is the overtopping risk during construction, e.g., Clermont weir in April 1963 and Chinchilla weir in 1972 and 1973. In addition, an efficient drainage system must be installed underneath the chute slabs.
